Preliminary Assessment and Mapping of Maavah Mangrove - Report

October 2021

Prepared by *Enhancing National Development through Environmentally Resilient Islands* (ENDHERI) Project for the Ministry of Environment, Climate Change and Technology

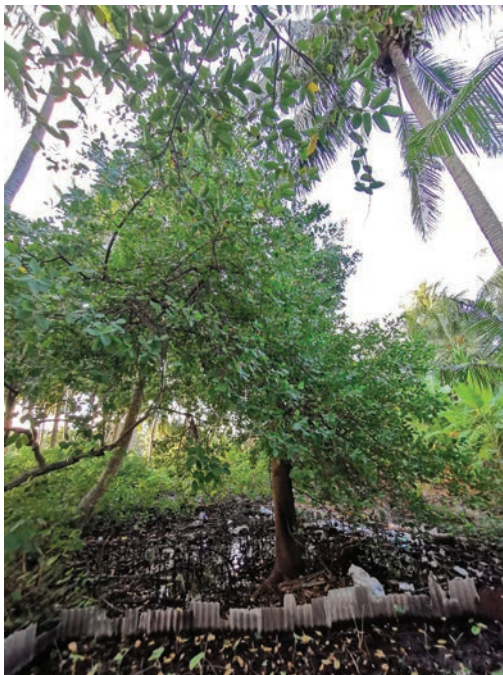
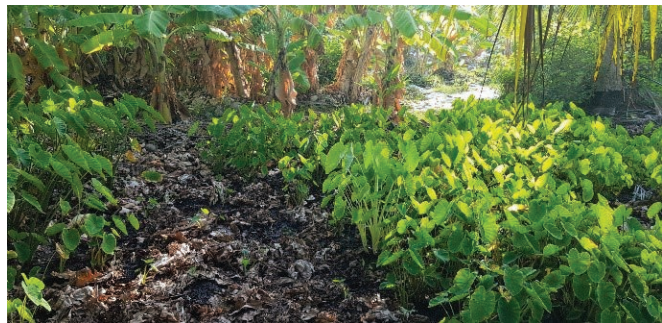
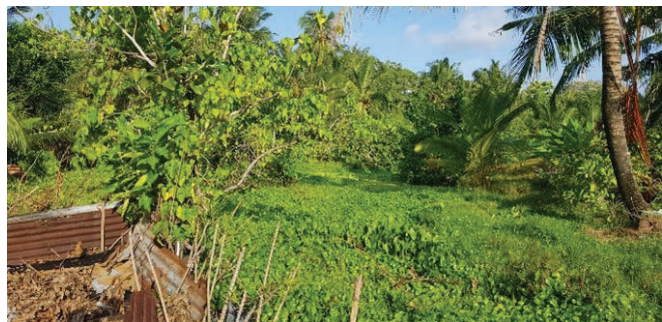
General observation of the mangrove shows heavy degradation of mangrove area, due to excessive dumping of waste and encroachment and farming activities. The area of mangrove is not recognizable as a mangrove due to absence key features of mangrove due to severe modification. Significant part of mangrove had, overgrown invasive plants and weeds, banana and taro plantations. Large number of cardboard boxes and mixed waste was observed at the remnant of the mangrove. A few mangrove plants such as Small-leaved Orange Mangrove “Kandoo” (*Bruguiera cylindrica*) and Mangrove Apple “Kulhavah” (*Sonneratia caseolaris*) species were observed sparsely distributed within the area.

According to the council, the taro and banana farming is carried out without proper permits from council. Additionally, due to limited land area and Island Waste and Resource Management Center (IWRMC) being few feet away from mangrove, waste disposal into the mangrove has increased, significantly impacting the ecosystem. The following timeline with Google earth images indicate the changes in mangrove vegetation over the years.

- The preliminary assessment of Maavah mangrove indicates that, the mangrove was once thick forest of mangrove species. The mangrove has been heavily modified, due to illegal farming activities within mangrove, encroachment, vegetation clearance and improper disposal of waste.

- A detailed vegetation survey, along with assessment of impacts to mangrove due to waste disposal and farming activities needs to be conducted in order to understand the extent of degradation.
