Environmental Monitoring Report

Project Number: 51077-003
Quarterly Report (January to March 2023)
June 2023

Maldives: Greater Male Waste-to-Energy Project

Prepared by the Ministry of Environment, Climate Change and Technology for the Ministry of Finance for the Asian Development Bank.

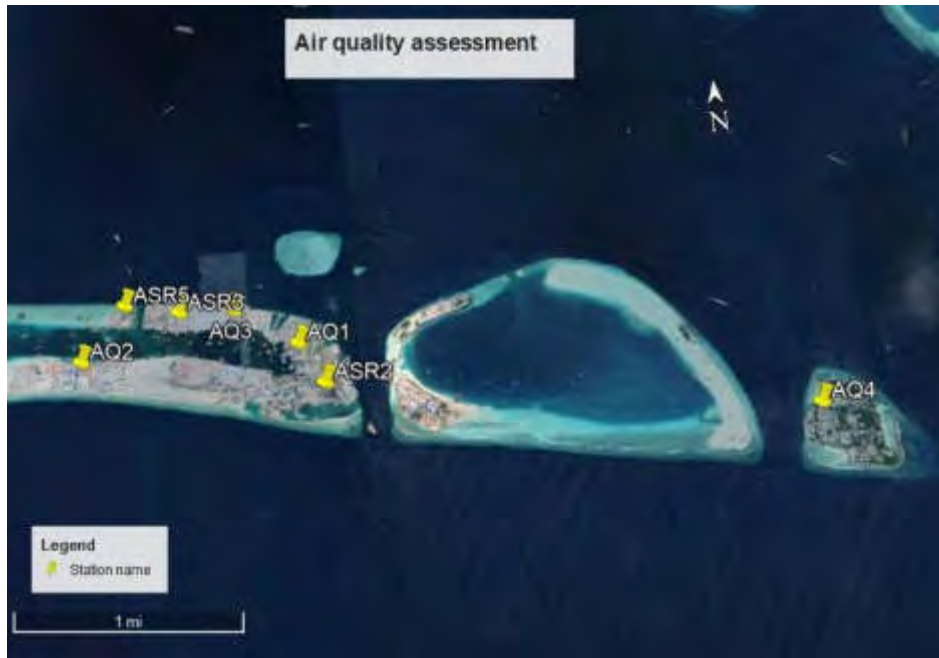
Figure 2: Ambient Air Quality Sampling Stations

35. For the additional baseline data gathering, ambient air quality sampling was conducted at seven locations: 6 locations at Thilafushi (AQ1, AQ2, and AQ3 identified as baseline stations in the EIA and the ASR2, ASR3 and ASR5 based on the AERMOD study in the EIA), and one location at Villingili (AQ4) as control station. Figure 2 shows the ambient air quality sampling stations. Table 13 gives the description of the sampling stations while Table 14, Table 15, and Table 16 show the summarized results of ambient air quality sampling in January 2023, February 2023, and March 2023, respectively. Detailed reports on ambient air quality sampling conducted are given in Appendix 2.

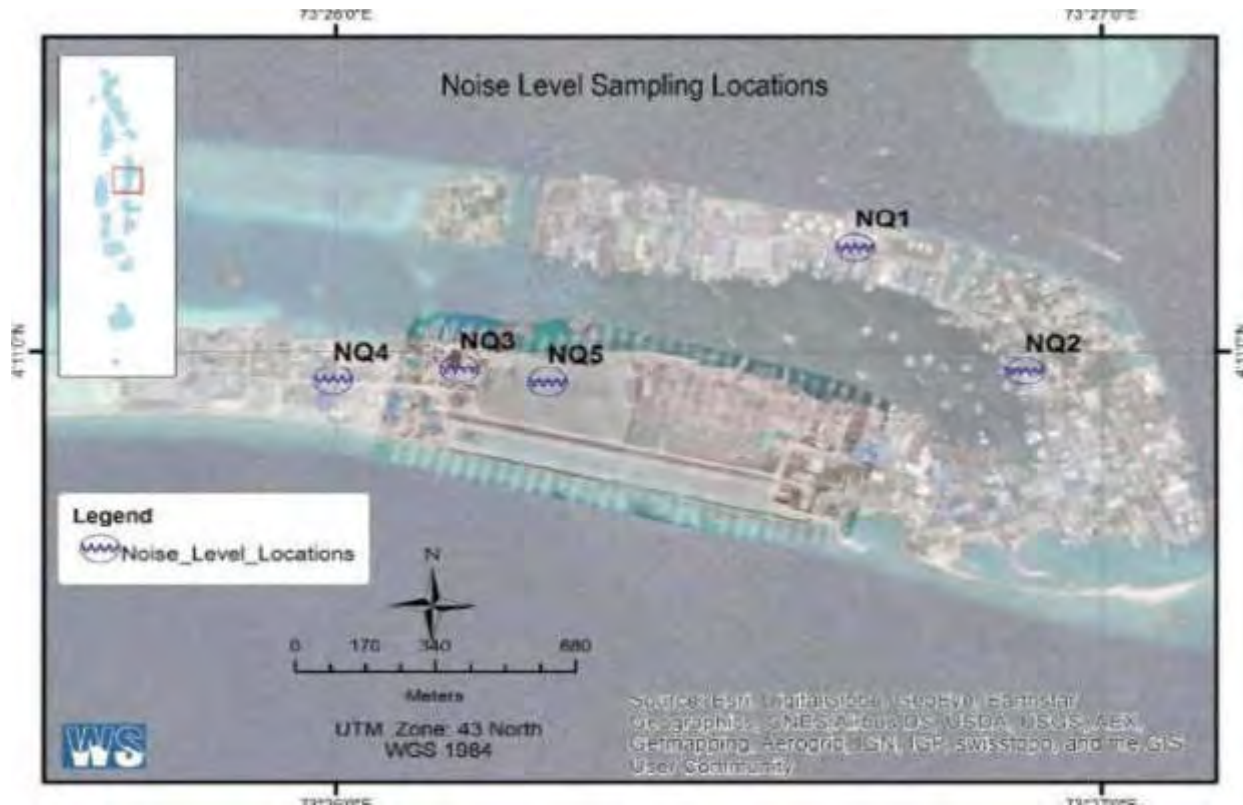
Figure 3: Noise Sampling Stations

40. Results of ambient noise levels were found to be within the applicable standards for commercial and industrial areas during reporting period i.e., from January to March 2023. Compared to the ambient noise levels measured on 25 August 2019 in the same sampling stations from the EIA (July 2020), monitored noise levels were found in same range, however variations in the results may be attributed to the commercial and industrial activities at the time of measurements.

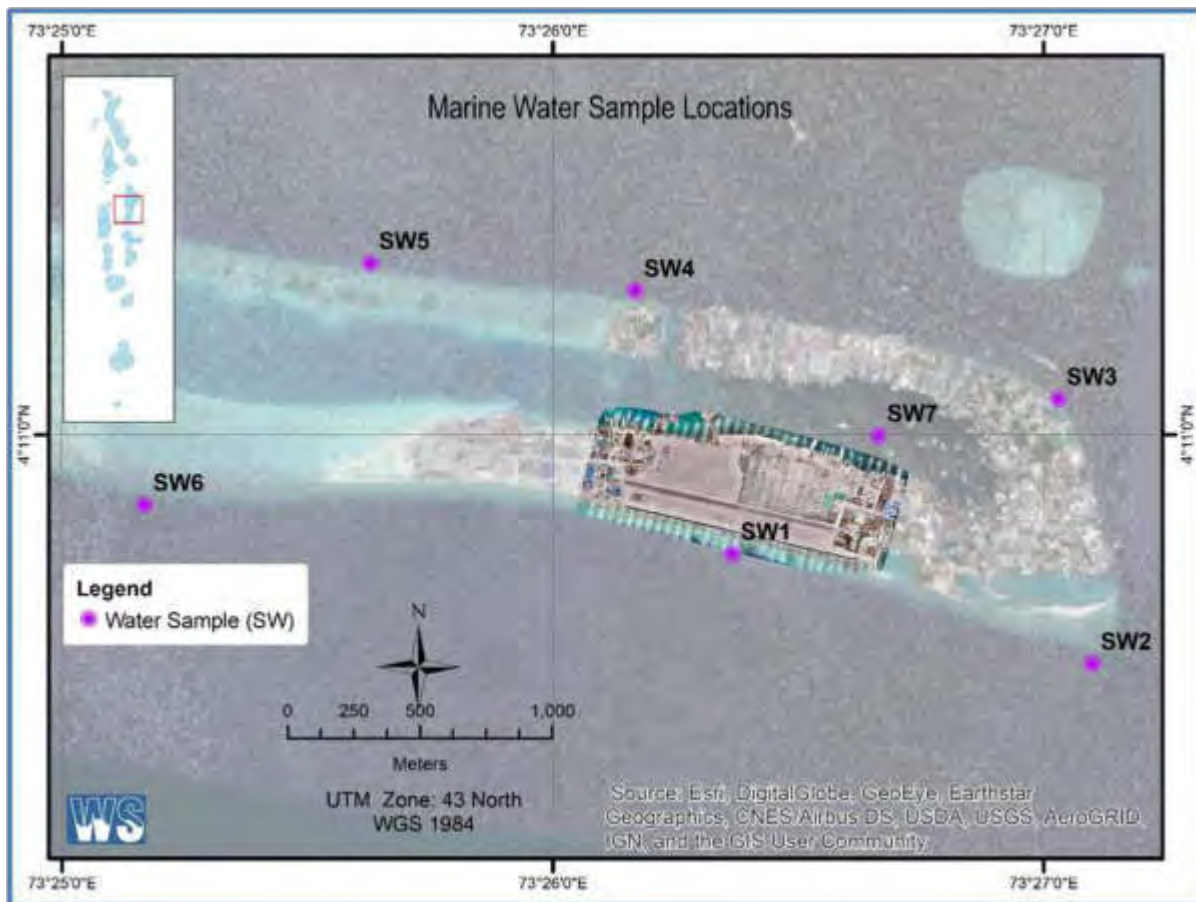
Figure 4: Marine Water Quality Sampling Stations

41. For the additional baseline data gathering, marine water quality sampling was done on 15 February 2023 from the same seven locations identified in the EIA (July 2020) given in Figure 4 below. Laboratory analysis of marine water was done by the Bureau Veritas Laboratory, Sri Lanka for the following parameters - heavy metals (As, Cr, Cu, Ni, Pb, Zn, Hg, Cd), total nitrogen, nitrites, pH, turbidity, five-day biochemical oxygen demand (BOD)₅ etc (see Table 19). The samples were brought to Sri Lanka and delivered to the laboratory within 24 hours from the field sampling. All the samples are kept in ice boxes to maintain the appropriate temperature and to conserve the samples. In-situ recording of pH, dissolved oxygen (DO), and electrical conductivity (EC) for each sample was conducted by using a handheld Hach SensION +MM156 water quality measurement meter. These results (Table 19) show compliance to the Maldivian Marine Monitoring Standards [Reference: Great Barrier Reef Marine Park Authority (2009) Outlook Report 2009]. Laboratory test results of marine water samples are given in Appendix 3.

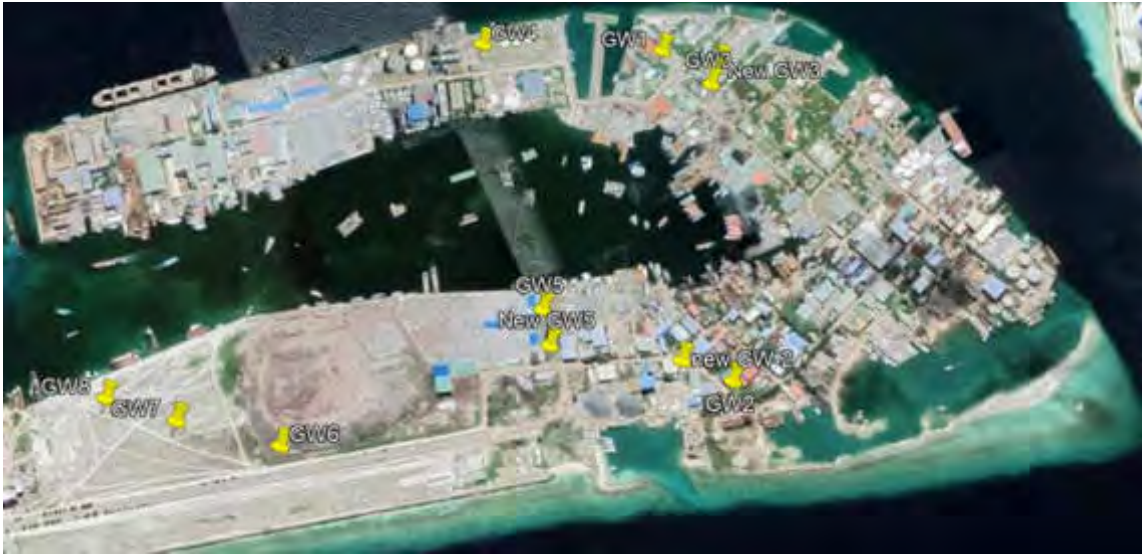
Figure 5: Groundwater Quality Sampling Stations

46. Results from Table 20 show that levels of PAH and heavy metals were found to be below detection limit while other parameter are: oil & grease (ND in GW1 and 0.9 mg/l in GW5), TSS (ND in GW1, GW2, GW6, GW7 & GW8 and 680 mg/L in GW5), electrical conductivity (13.5 $\mu\text{S}/\text{cm}$ in GW3 to 49425 $\mu\text{S}/\text{cm}$ in GW4), Faecal coliform (< 1.8 MPN/100 ml at all locations), pH (6.5 in GW1 to 8.3 in GW3), chloride (77.8 mg/L in GW1 and GW8 to 8640 mg/L in GW5), and nitrate (ND mg/L in GW1, GW7 & GW 8 to 0.6 mg/L in GW2 & GW5).

47. From the EIA (July 2020), samples were collected in the same sampling stations on 2 April 2019. Values of PAH, oil & grease, and heavy metals were found to be below the detection limit while for other parameters are: TDS (794 mg/L in GW1 to 12,946 mg/L in GW3), electrical conductivity (1.39mS/cm in GW1 to 25mS/cm in GW6), total coliform (4 MPN/100 ml in GW8 to >2,420 MPN/100 ml in GW1, GW3, GW5, and GW7), pH (7.1 in GW5 to 8.0 in GW4), chloride (183mg/L in GW1 to 6,325mg/L in GW6), and nitrate (1.7mg/L in GW1 to 34.5 mg/L in GW6).

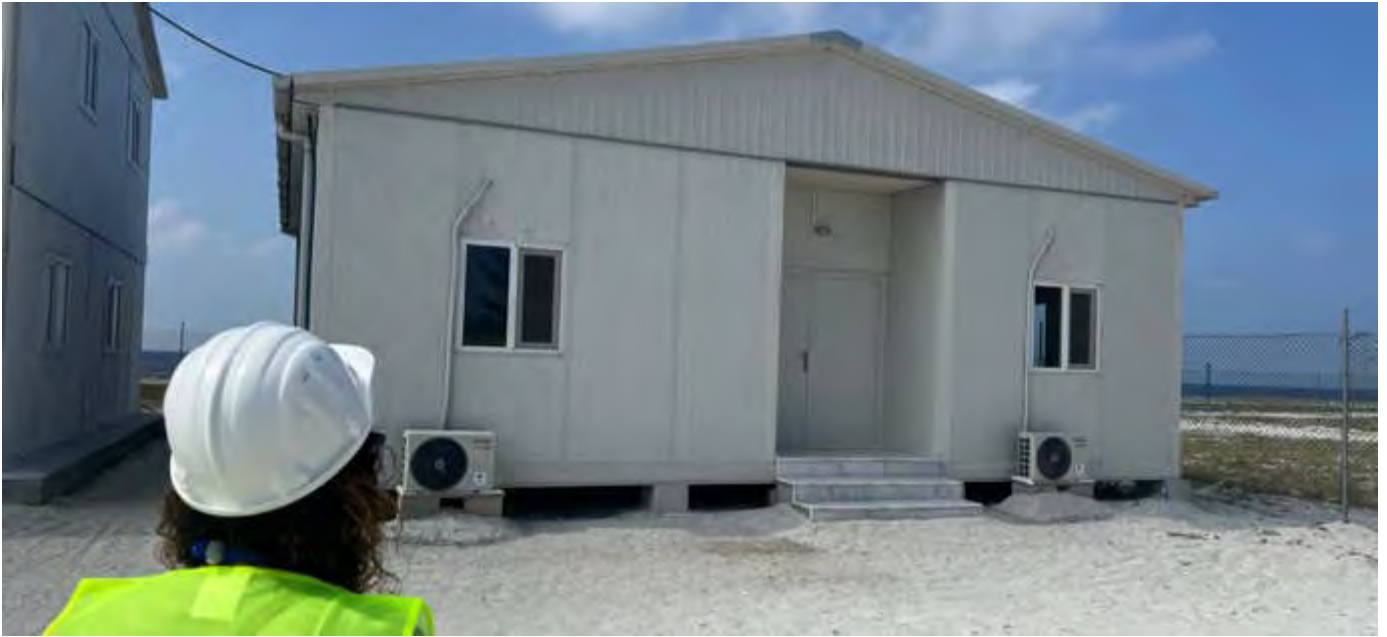
Photo 01 by Naahee 18/02/23 09:33hrs.
E.R. office and accomidation building completed.

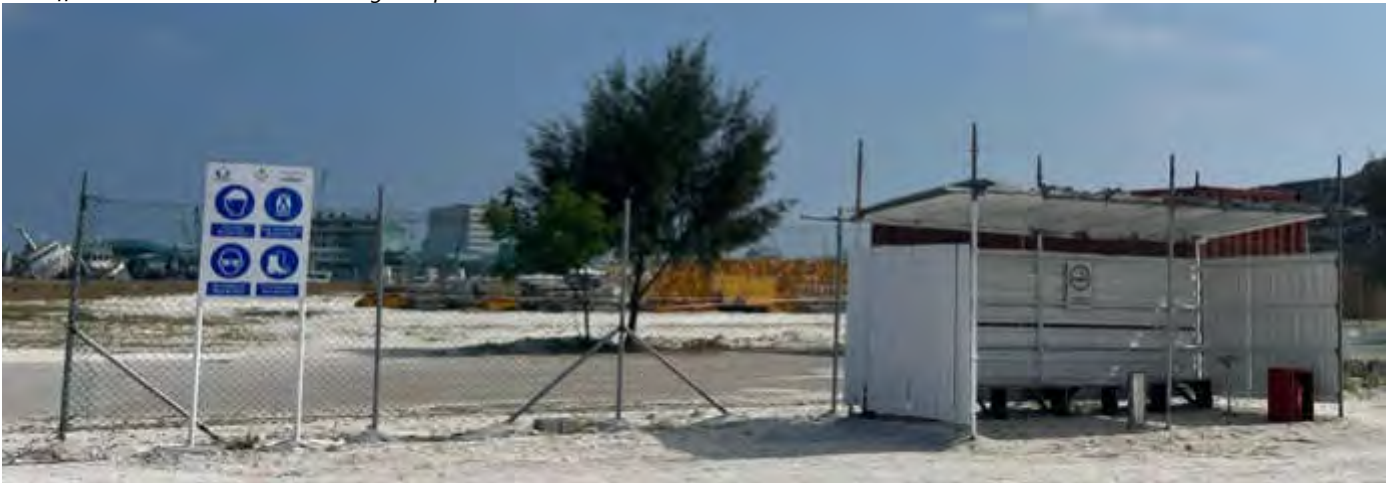
Photo 02 by Naahee 18/02/23 09:33hrs.
Designated smoking area and safety signage around the site, workers area is separated by a fence within the site area.

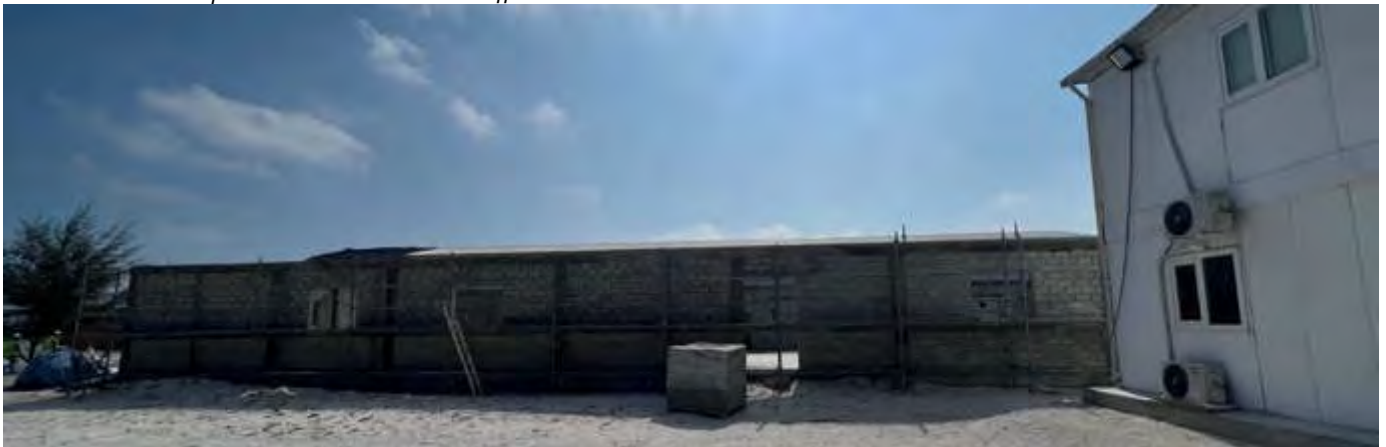
Photo 04 by Naahee 18/02/23 09:34hrs.
Construction of mess hall ongoing.

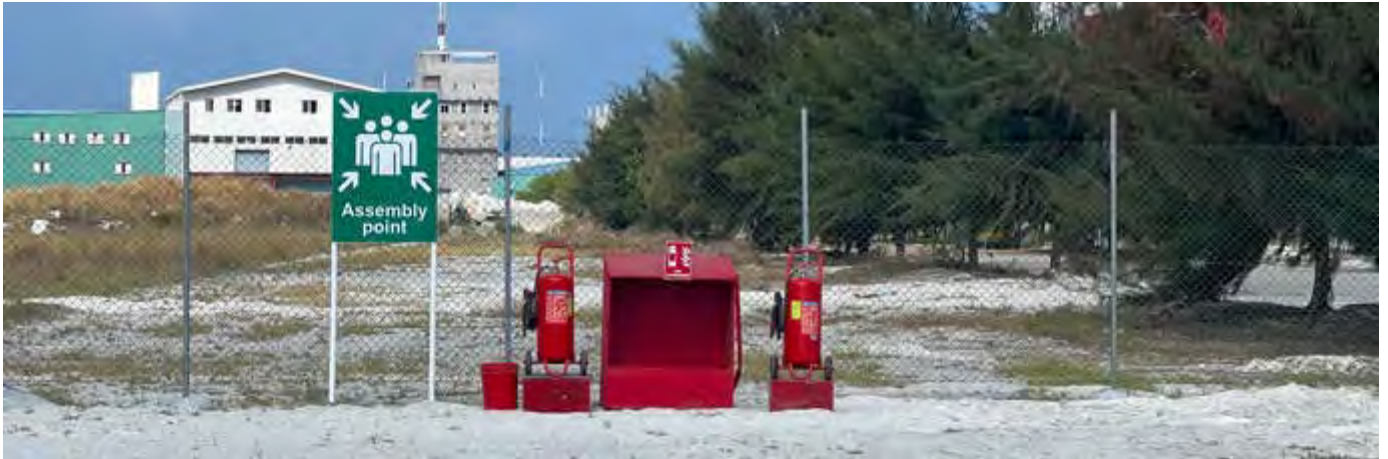
Photo 06 by Naahee 18/02/23 09:36hrs.
Assembly point setup and fire fighting equipment placed.

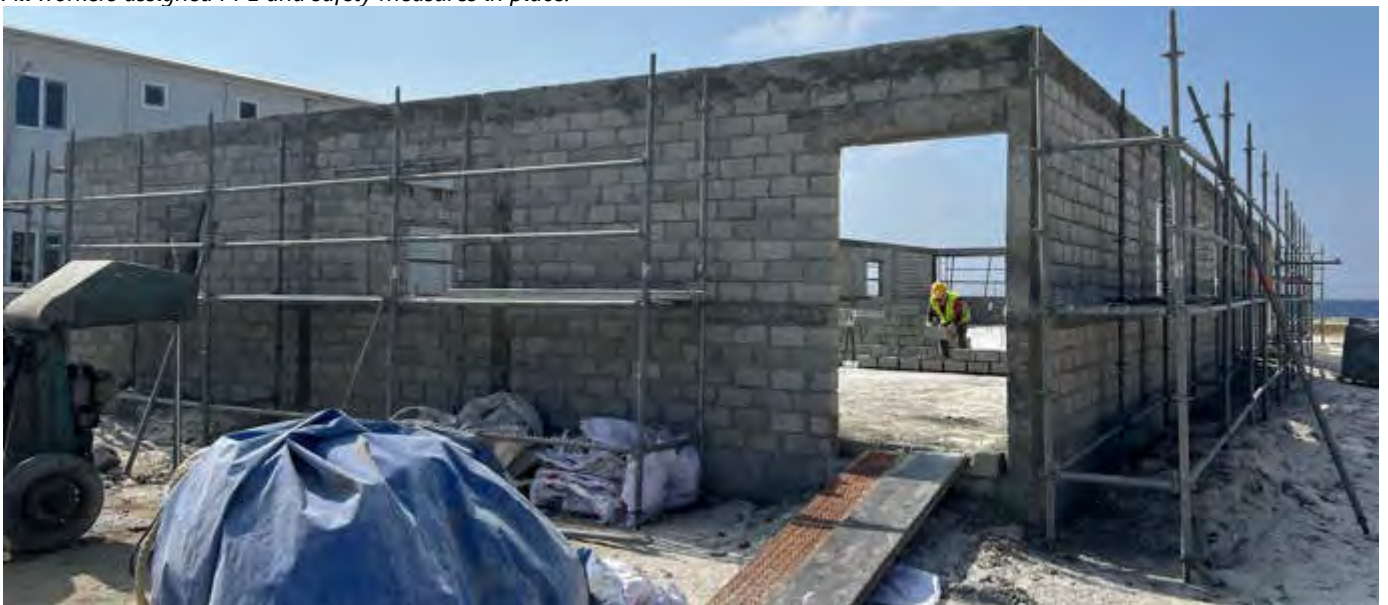
Photo 08 by Naahee 18/02/23 09:37hrs.
Construction ongoing for workers mess hall.

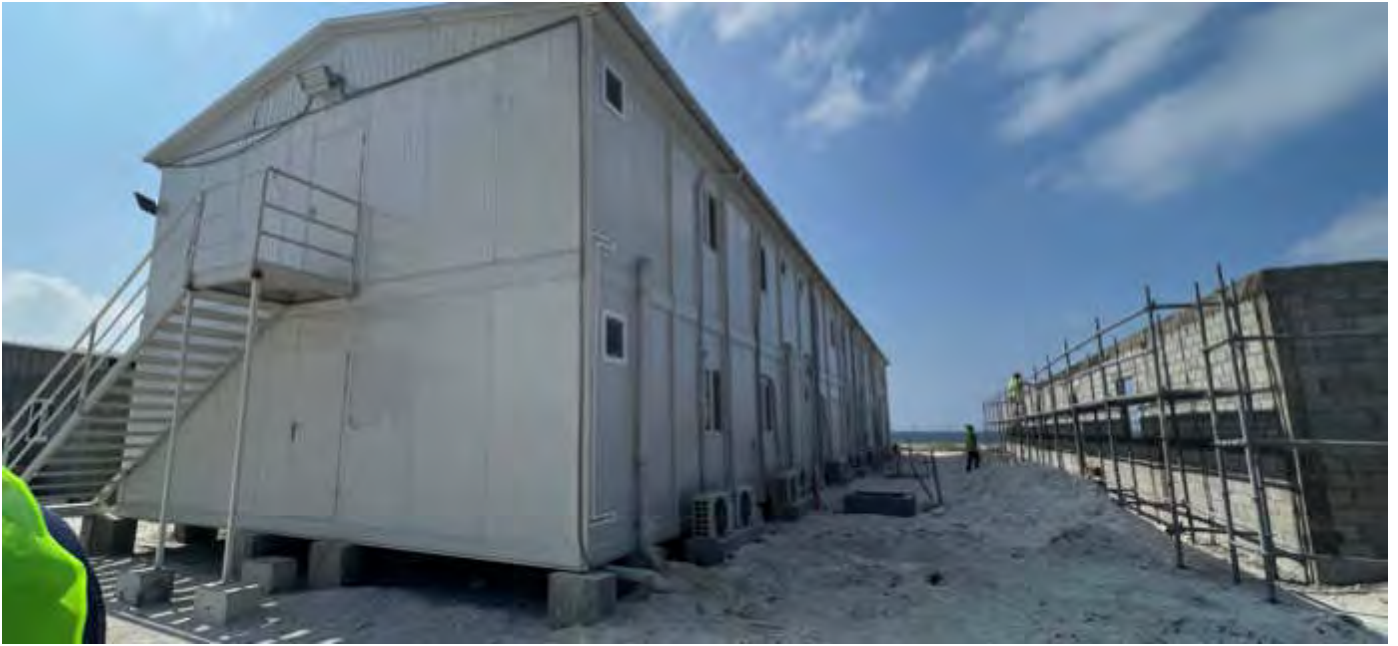
Photo 09 by Naahee 18/02/23 09:38hrs.
Fire escape stairs located on both ends of the hallway in the staff accommodation building, building completed.

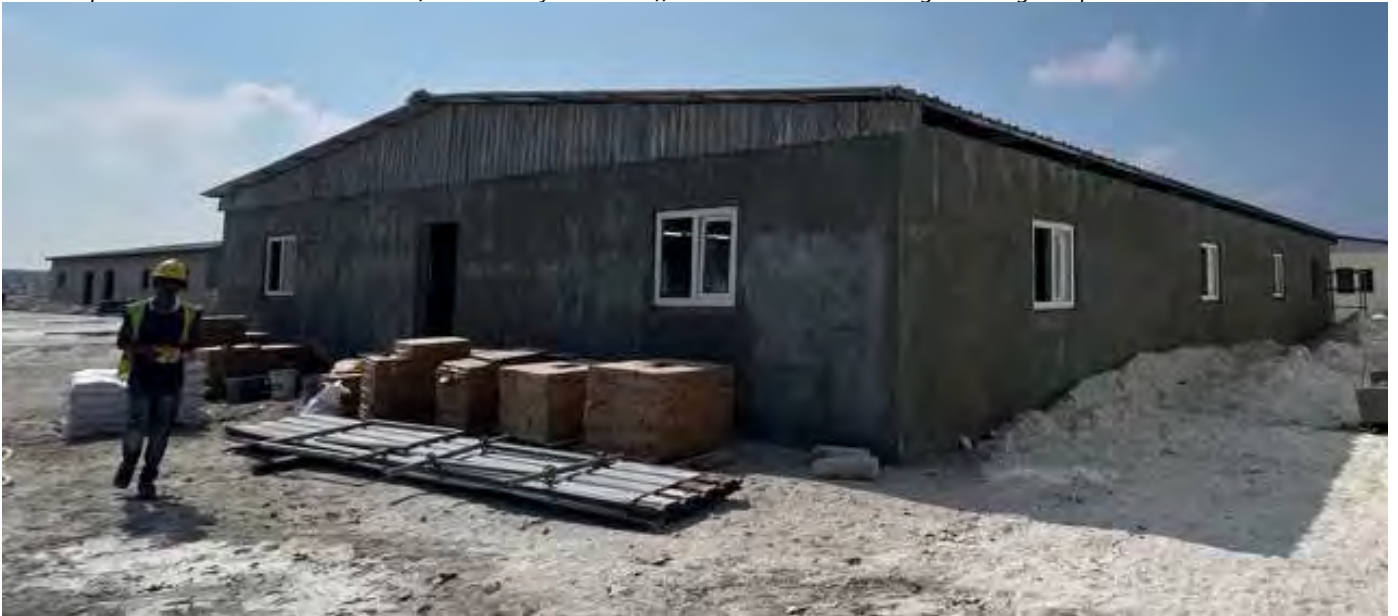
Photo 10 by Naahee 18/02/23 09:38hrs.
Prayer hall and recreation center under construction.

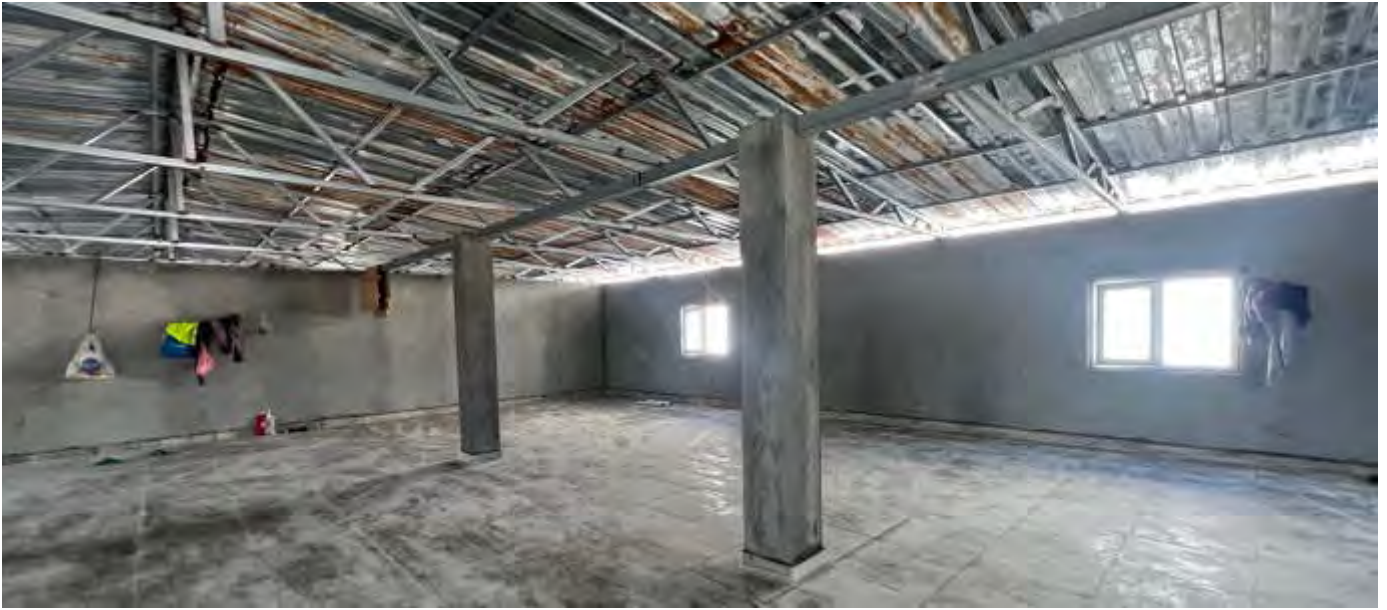
Photo 11 by Naahee 18/02/23 09:39hrs.
Prayer hall under construction.

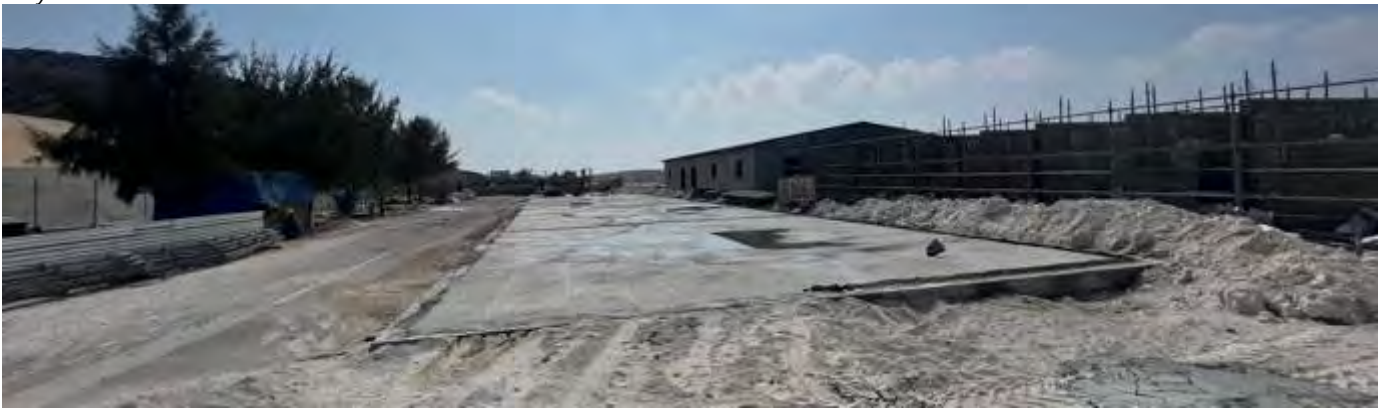
Photo 12 by Naahee 18/02/23 09:40hrs.
Construction of temporary facilities, workers accommodation building ongoing.

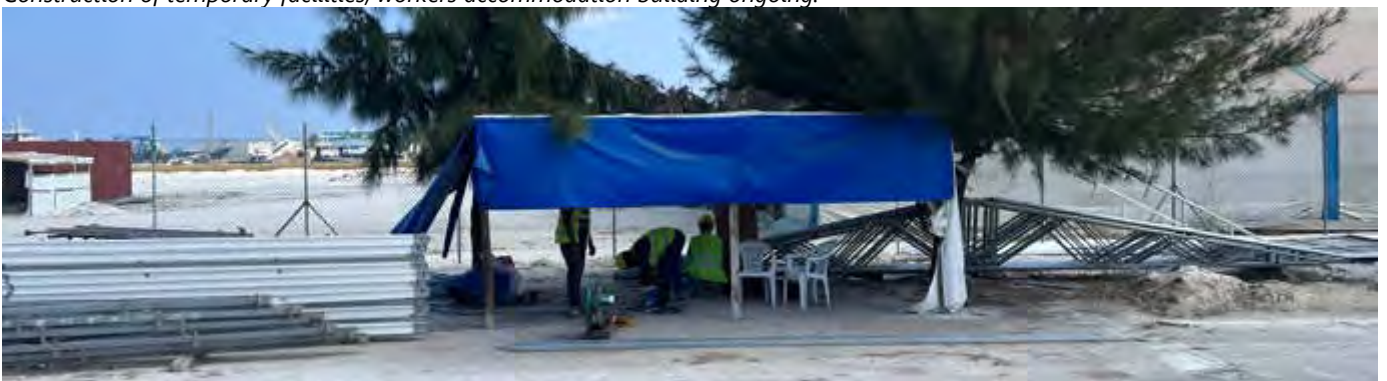
Photo 13 by Naahee 18/02/23 09:40hrs.
Metal fabrication work ongoing, all workers with PPE.

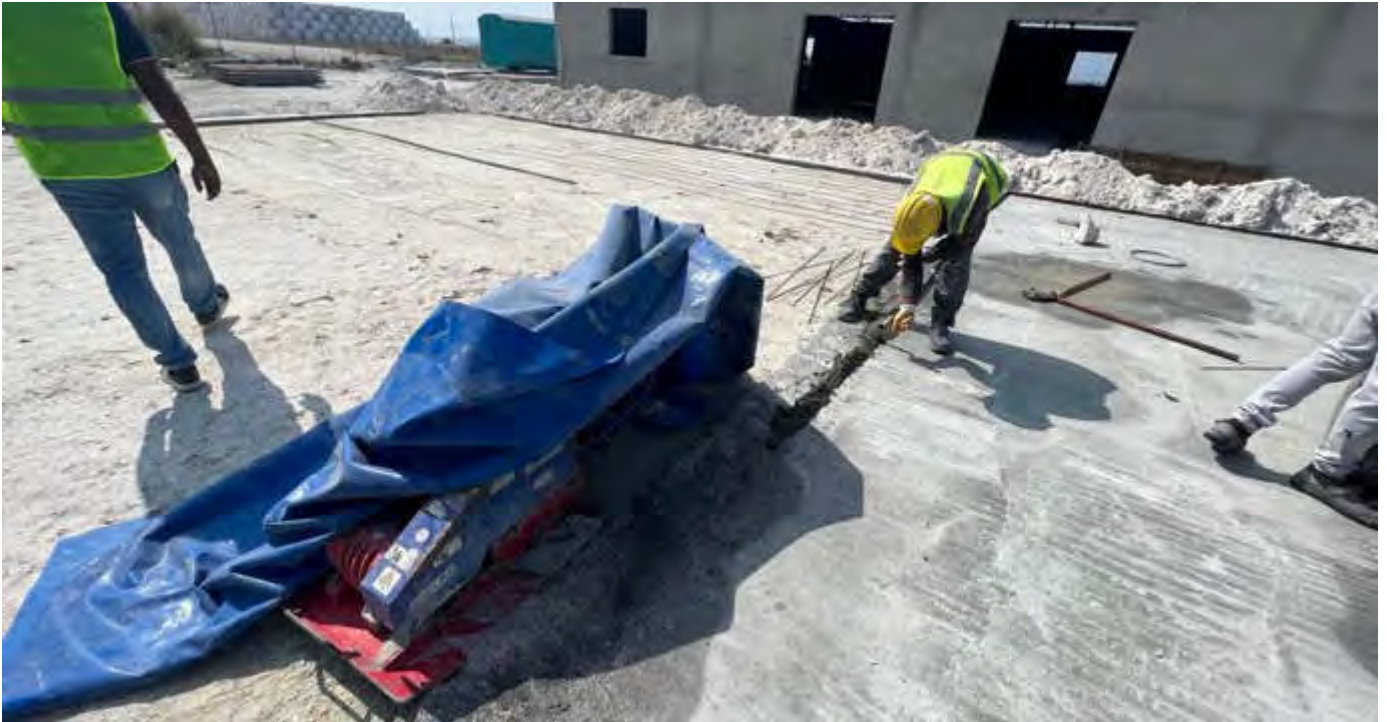
Photo 14 by Naahee 18/02/23 09:41hrs.

Flooring works for temporary facilities, workers accommodation buildings ongoing.

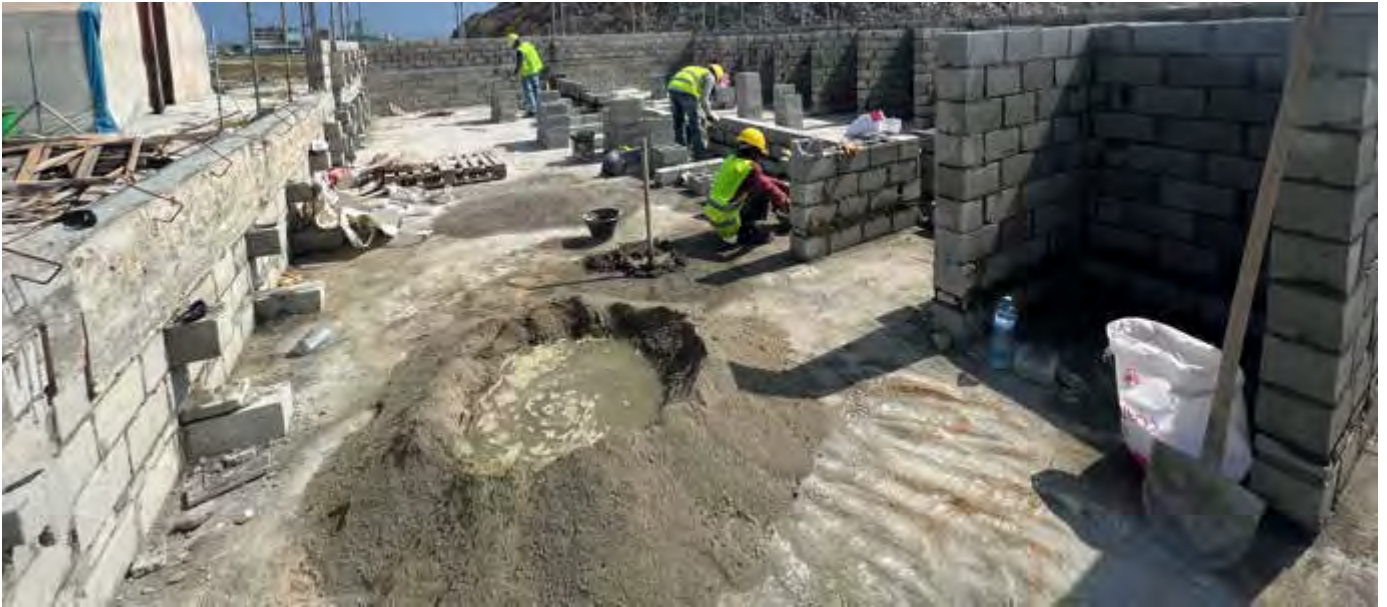
Photo 17 by Naahee 18/02/23 09:43hrs.

Masonry work for the workers accommodation building in progress, full blocks used, with reinforced concrete framing.

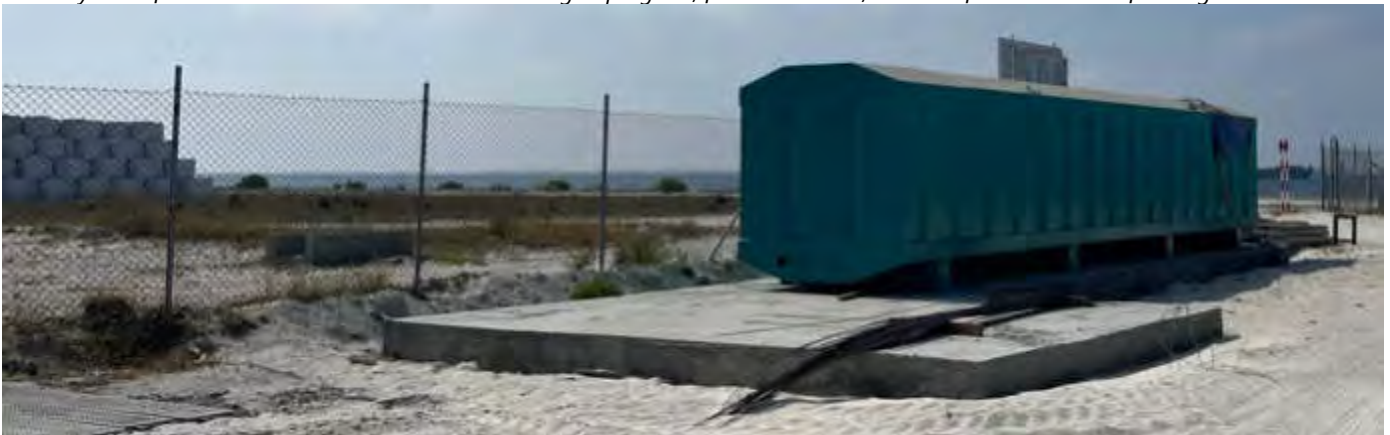
Photo 18 by Naahee 18/02/23 09:45hrs.

WWTP connections yet to be made, and is not operational, currently temporary storage tanks and MWSC pump trucks still being utilized.

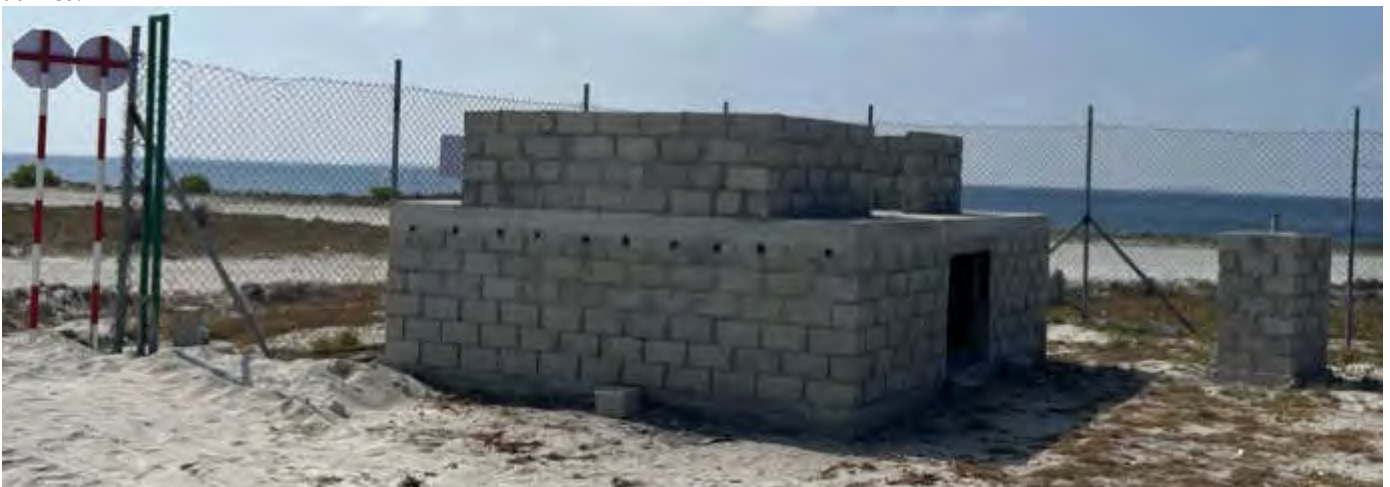
Photo 19 by Naahee 18/02/23 09:47hrs.

Security guard post/tower under construction at the main site entrance, semi-permanent survey control points placed around the site as seen to the right bottom corner of this photo, and shall remain in place till completion of the project.

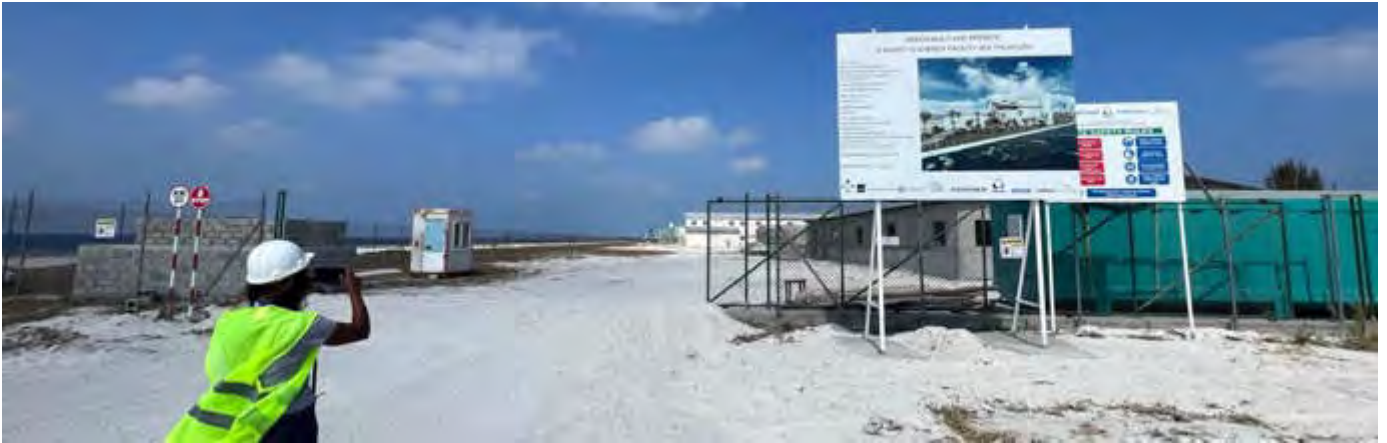
Photo 20 by Naahee 18/02/23 09:48hrs.
Main site entrance with Project Sign Board in place, and gates in place.

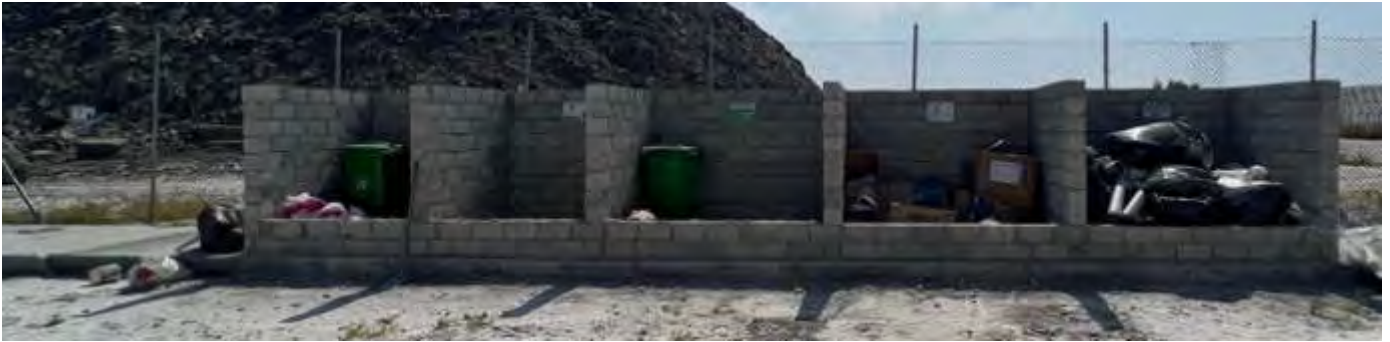
Photo 25 by Naahee 18/02/23 09:58hrs
Waste collection area setup and in use.

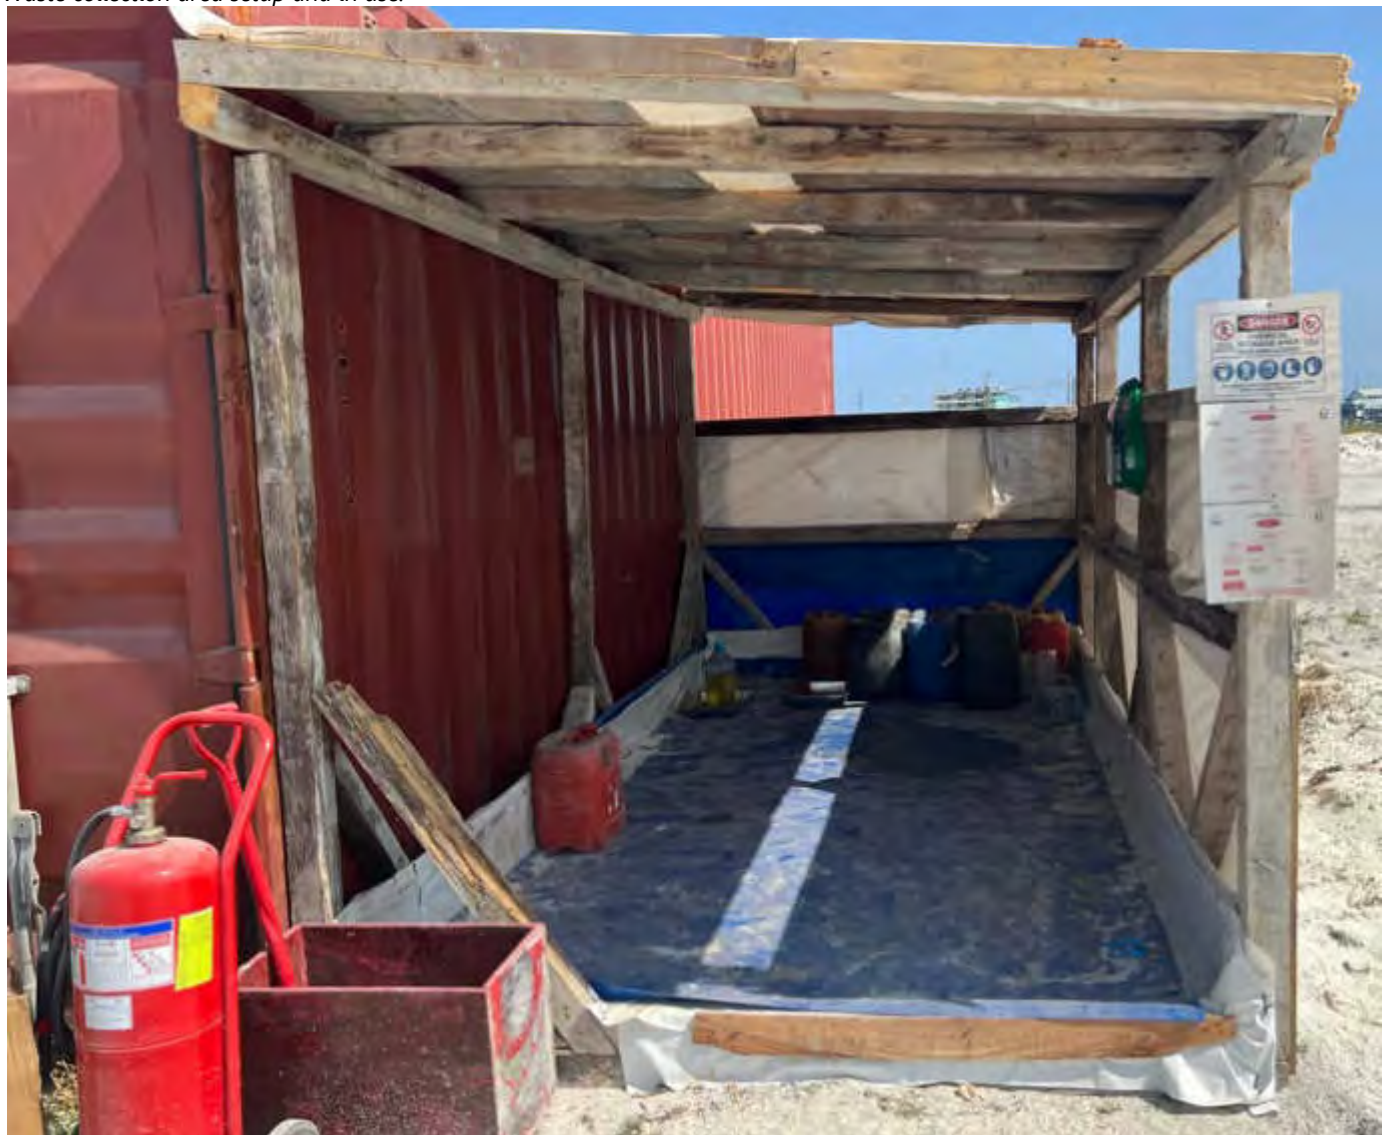
Photo 26 by Naahee 18/02/23 09:56hrs
Hazardous chemical storage not completed yet, work is on going and to be completed soon.

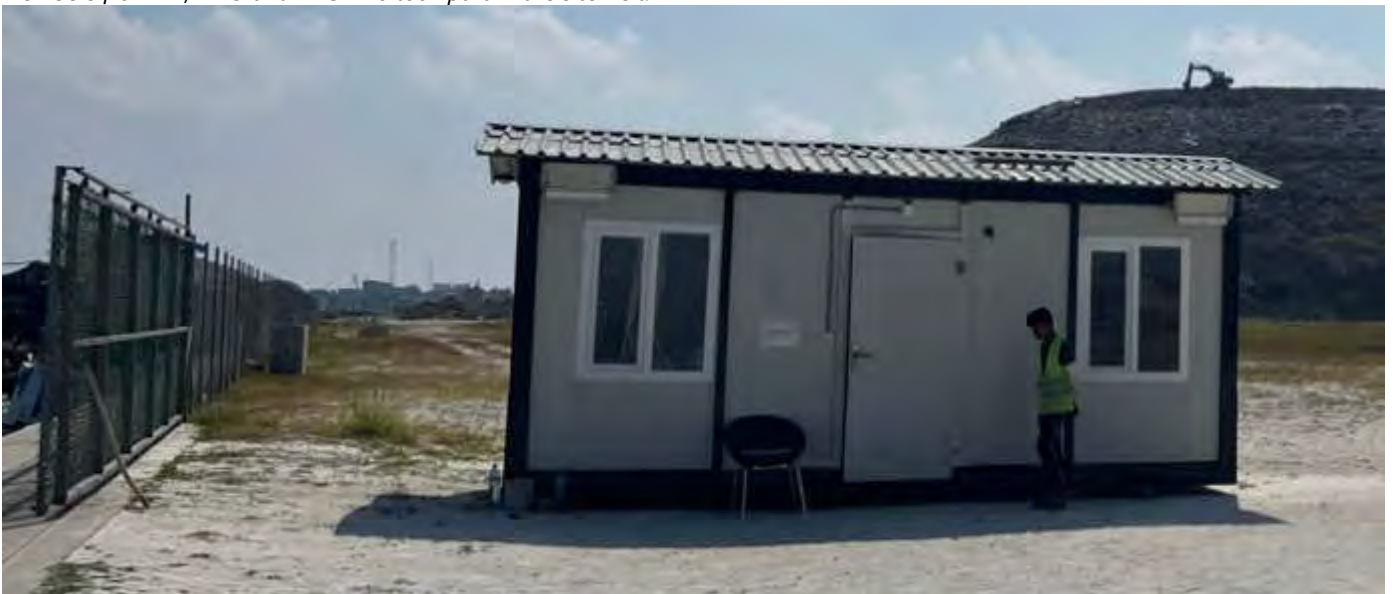
Photo 29 by Naahee 18/02/23 10:08hrs
Manned security guard post, at the entrance gate on the seaside quay wall area, this is where the speed boat offloads all workers on and visitors onto site.

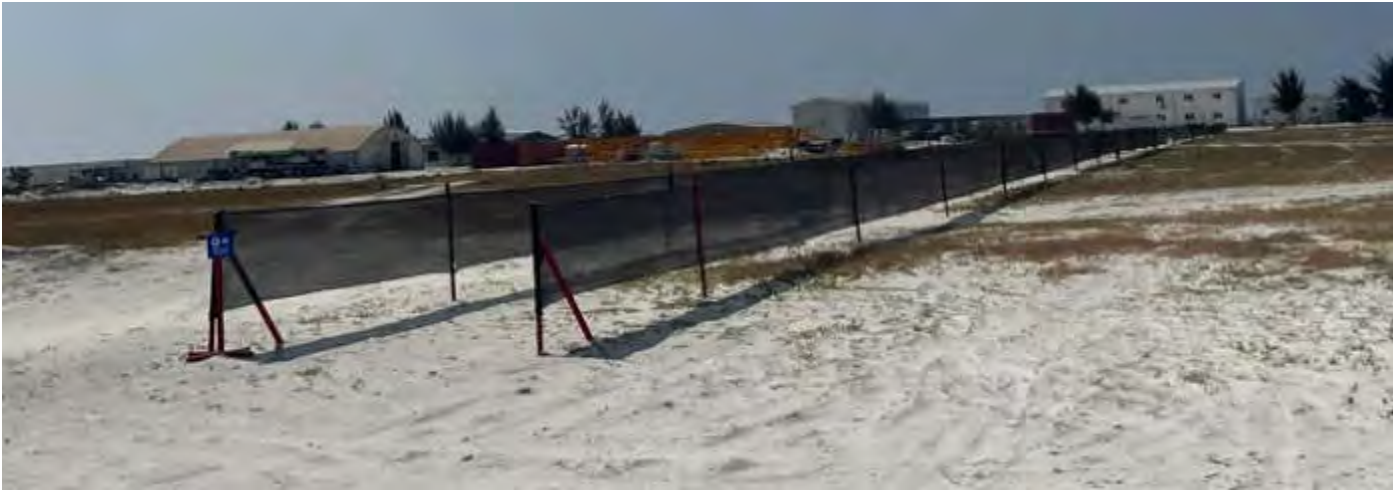
Photo 30 by Naahee 18/02/23 10:09hrs

Railings placed along the walk path from the sea side entry gate to the workers area.

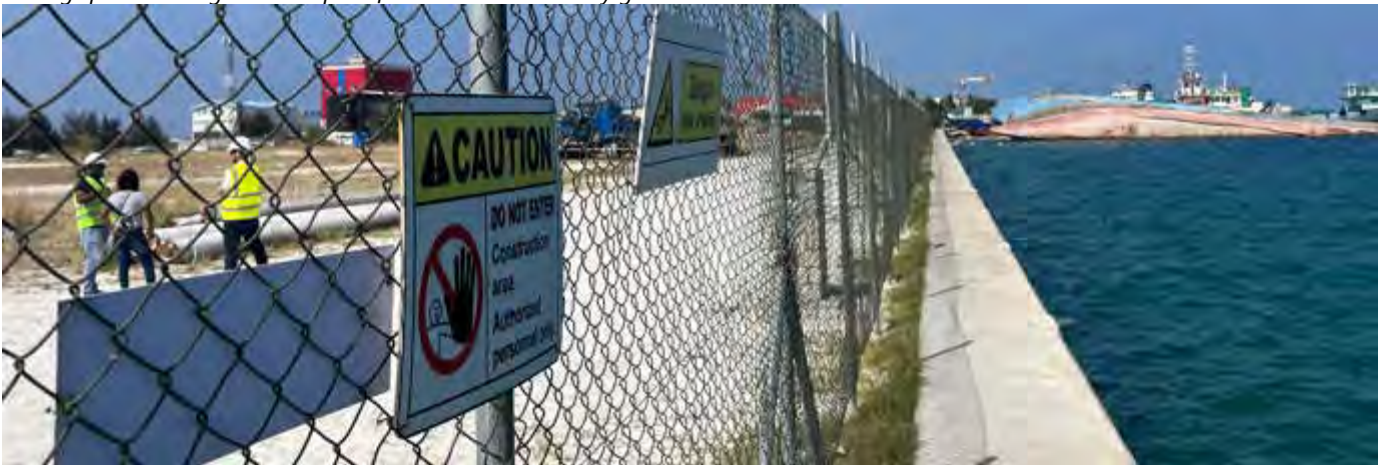
Photo 31 by Naahee 18/02/23 10:10hrs

Site boundary fence along the quay wall with signage placed, the shipwrecks outside the site boundary still remain.

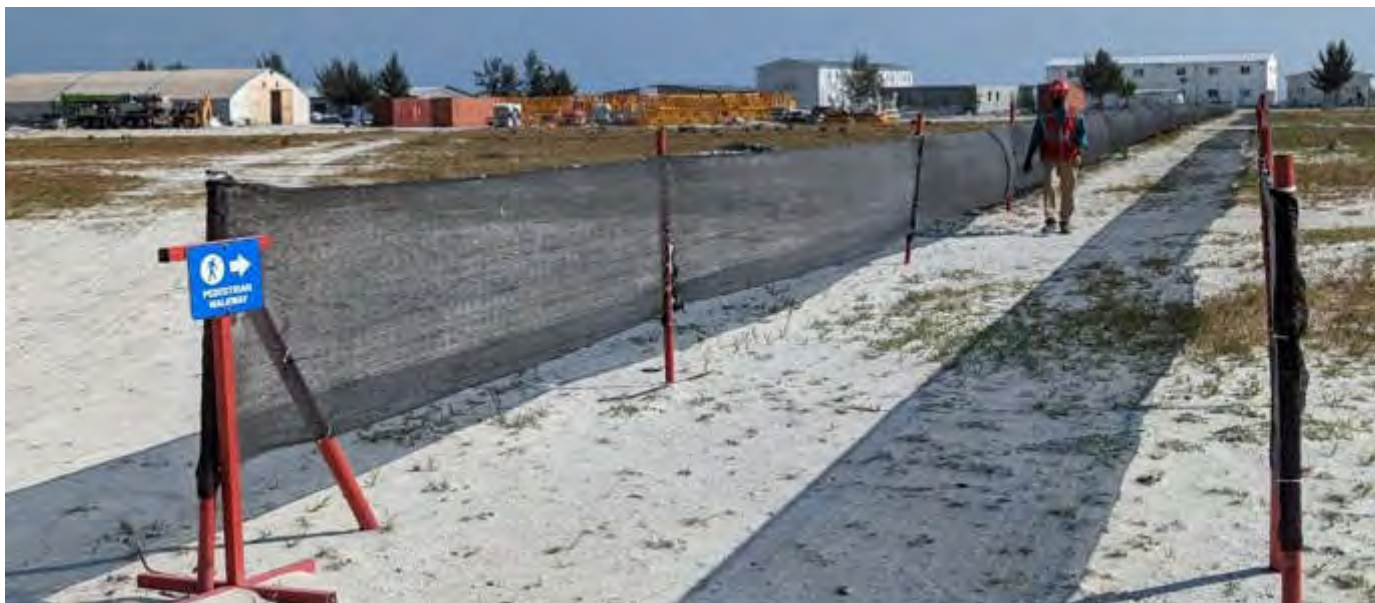
Photo 01 by Naif 27/02/23 15:33hrs.
Pedestrian protected path from the site entrance to. Workers camp..

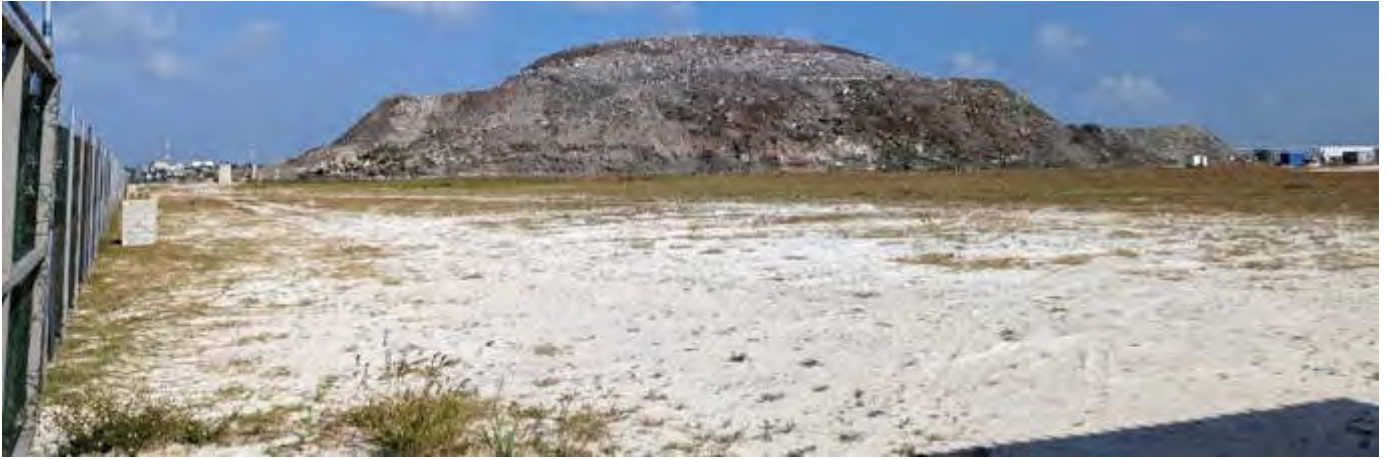
Photo 04 by Naif 27/02/23 15:40hrs.
WAMCO landfill and fencing works incomplete.

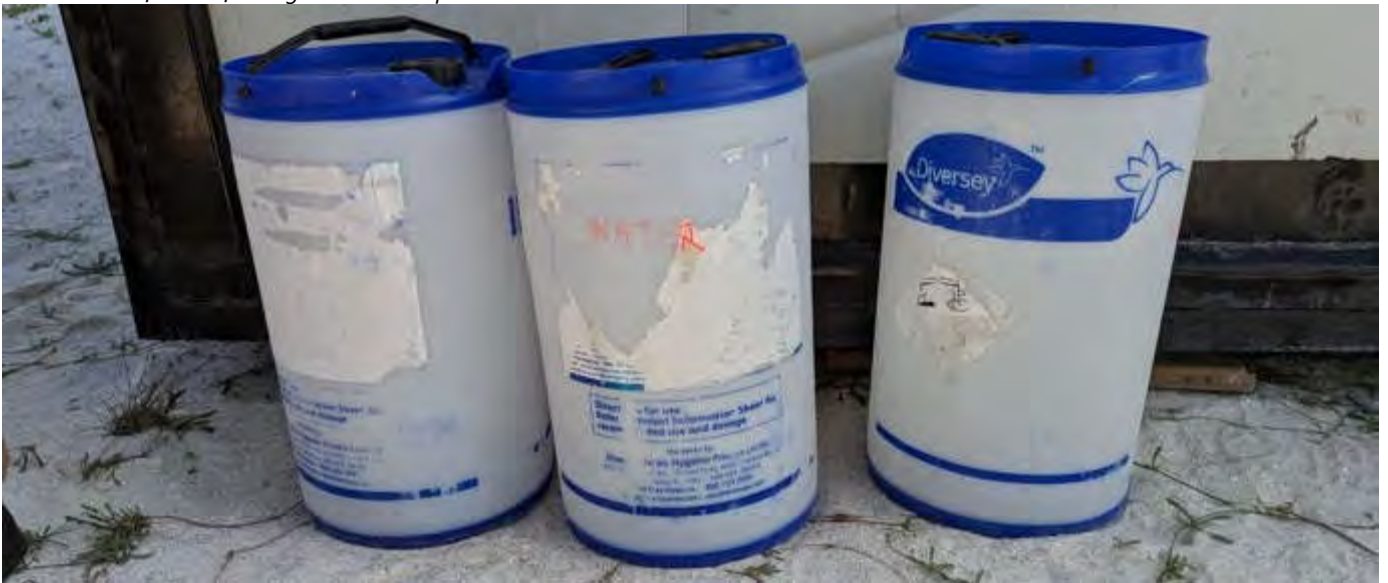
Photo 05 by Naif 27/02/23 15:35hrs.
Water stored in hazardous chemical storage containers, this should be avoided.
