Environmental Monitoring Report

Project Number: 51077-003
Quarterly Report (January to March 2023)
June 2023

Maldives: Greater Male Waste-to-Energy Project

Prepared by the Ministry of Environment, Climate Change and Technology for the Ministry of Finance for the Asian Development Bank.

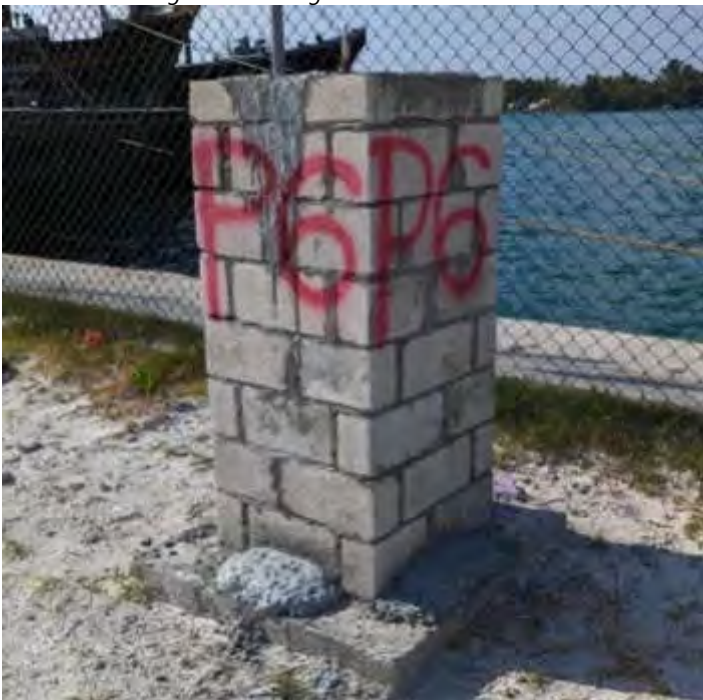
Photo 09 by Naif 27/02/23 15:58hrs.
P6 survey control point established, several control points established around the site, these will remain in place until completion of project.

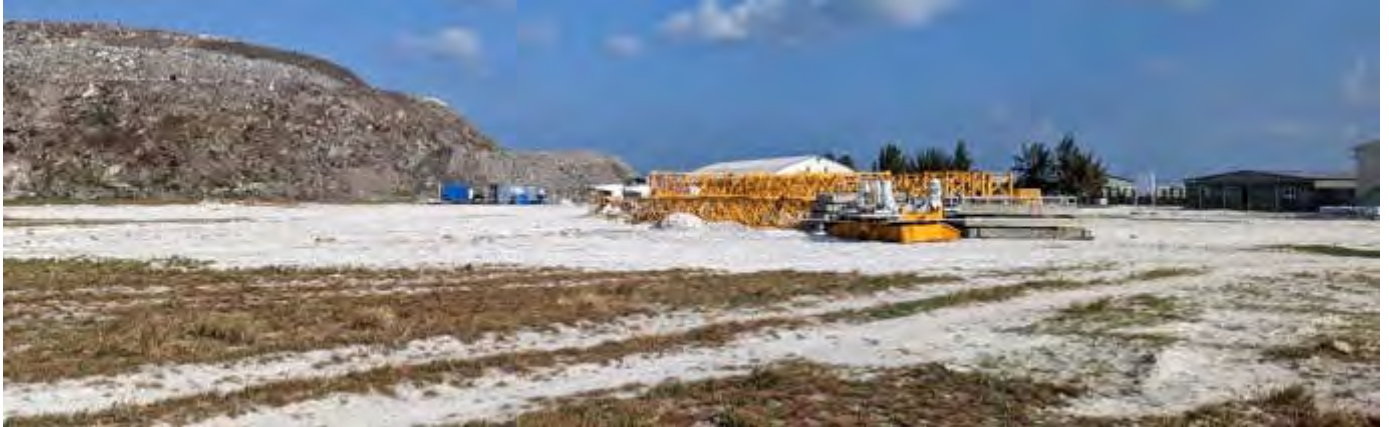
Photo 10 by Naif 27/02/23 16:00hrs.
Health and safety related posters placed at the site security post,

Photo 11 by Naif 27/02/23 16:02hrs.
Tower crane delivered to site, yet to be setup and established.

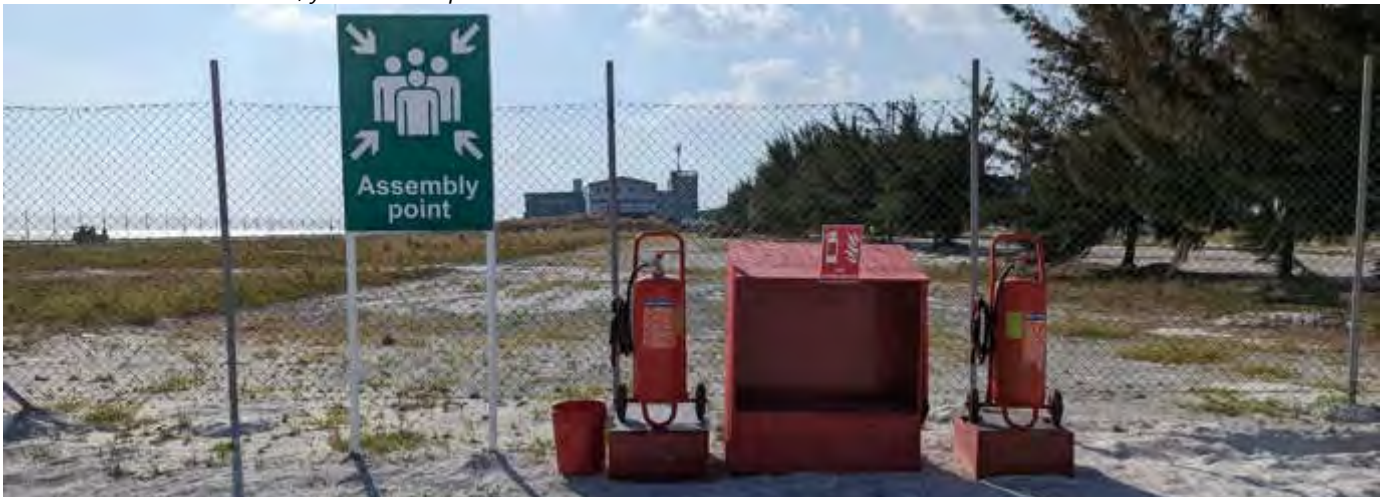
Photo 12 by Naif 17/02/23 16:10hrs.
Emergency assembly point setup at the site, within the workers camp.

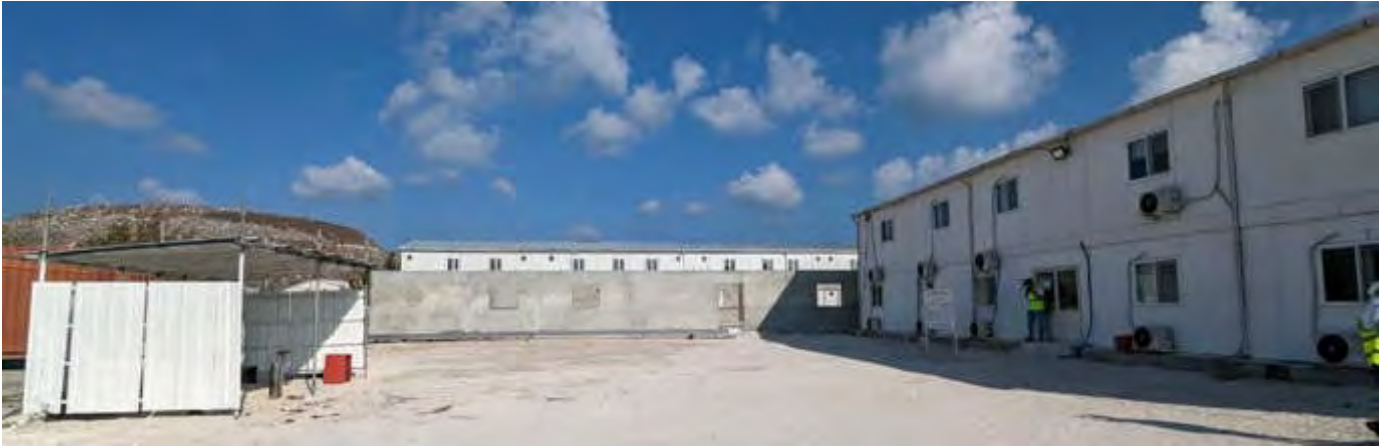
Photo 13 by Naif 27/02/23 16:12hrs.

Smoking area, workers dining mess, and contractors site office established within the worker camp.

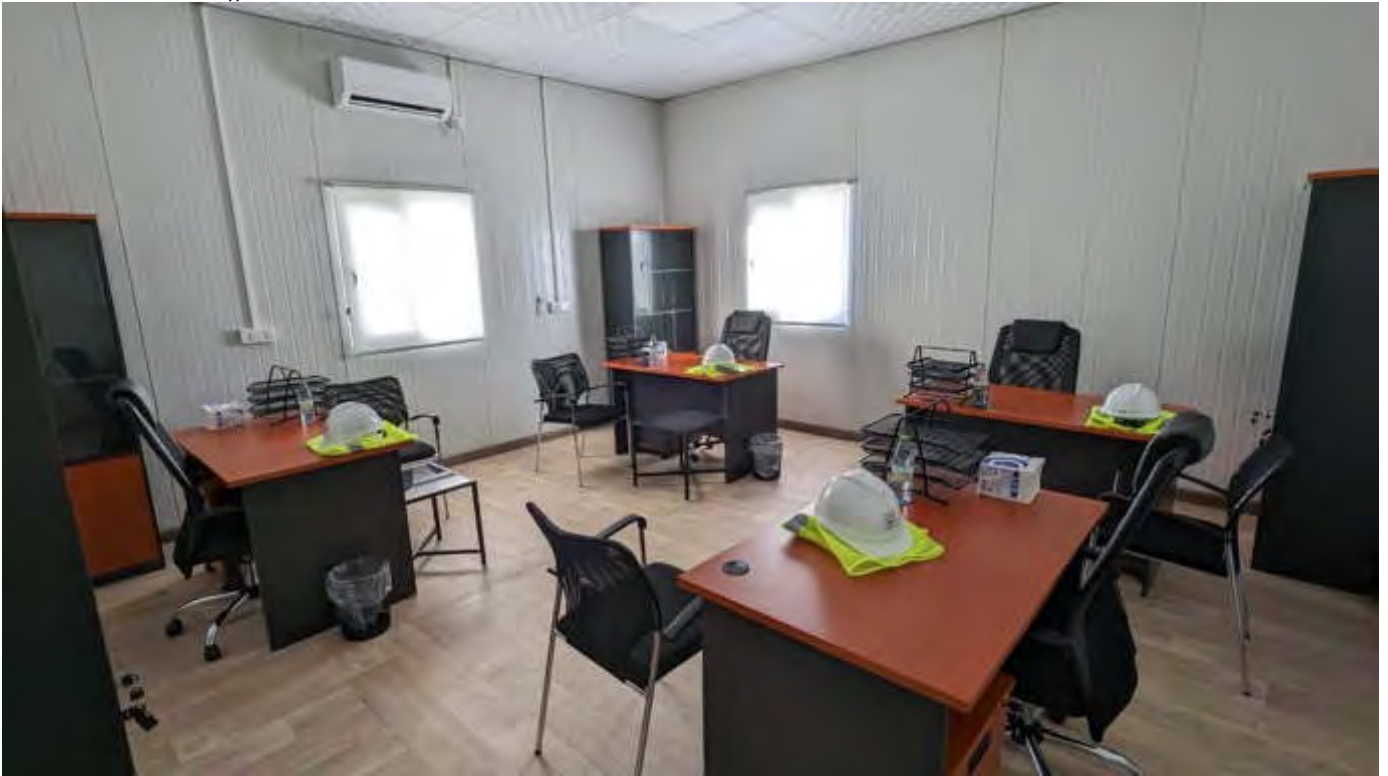
Photo 17 by Naif 27/02/23 16:22hrs.
ER site office completed, and ready to be used.

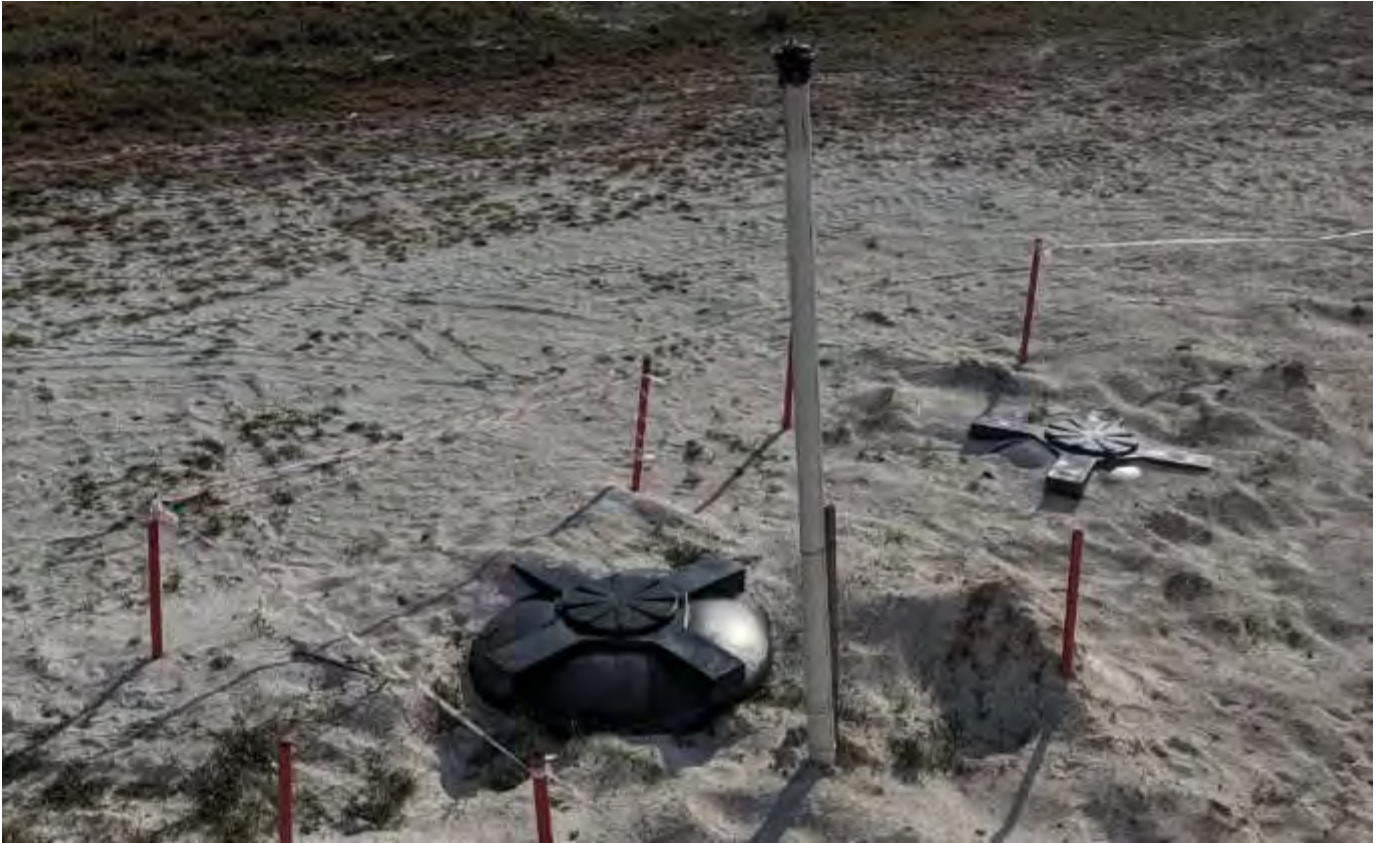
Photo 22 by Naif 27/02/23 16:30hrs.

Sewerage collection tanks established within the site, MWSC collection truck is still being used.

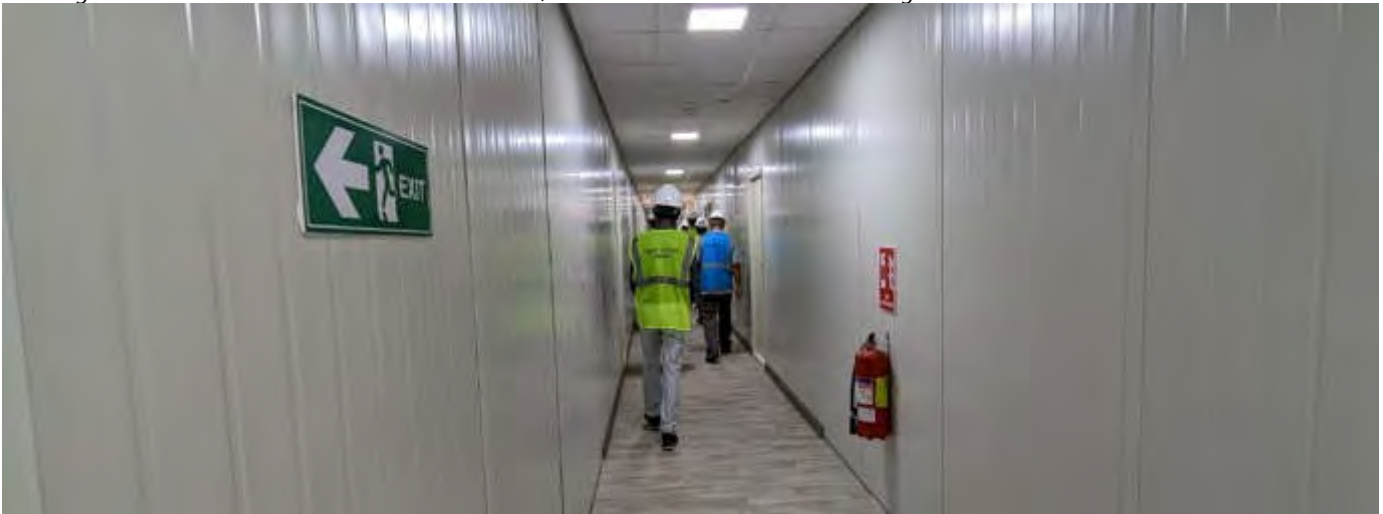
Photo 23 by Naif 27/02/23 16:31hrs.

E.P.C senior staff accommodation building on site, has been checked by MNDF and approved for use, in terms of fire fighting and fire escape requirements.

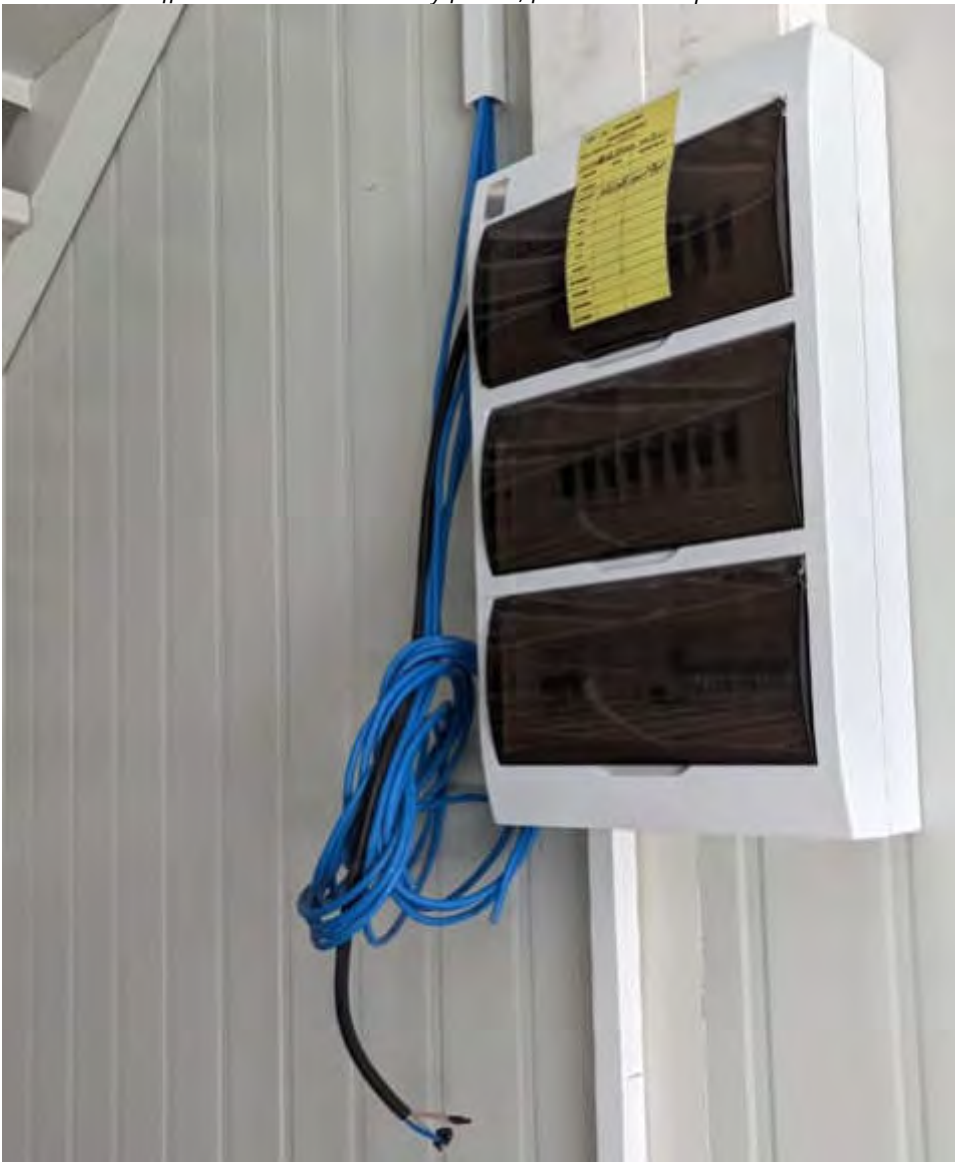
Photo 25 by Naif 27/02/23 16:35hrs.
Electrical cables and communication cables not in use, should be secured properly.

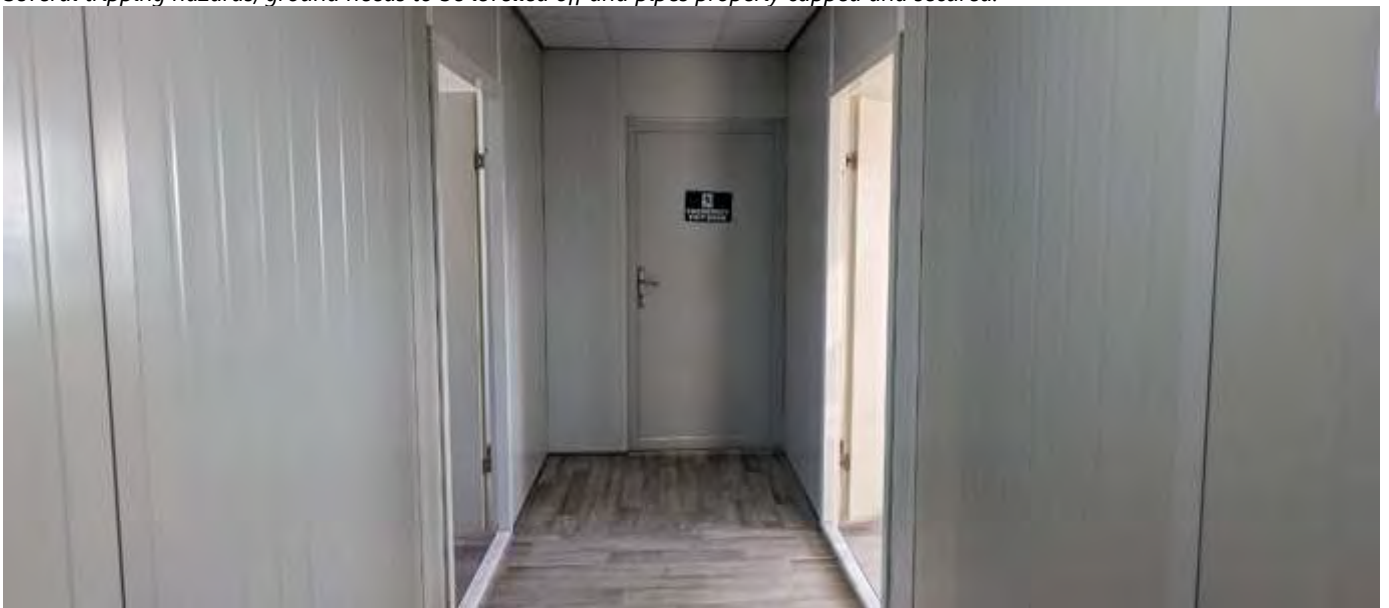
Photo 29 by Naif 27/02/23 16: 16:38hrs
Fire escape path marked out, and stairways provided on both ends of the hall way to the rooms.

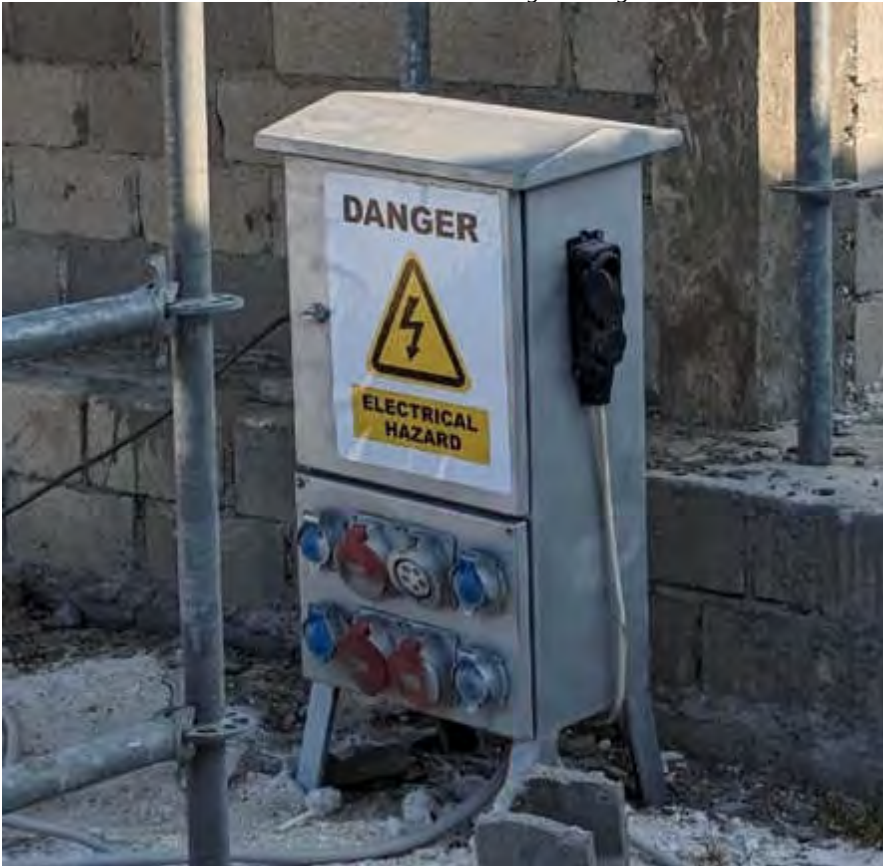
Photo 31 by Naif 27/02/23 16:42hrs
Temporary electric distribution board in use, the stands require to be higher for safety, from flooding, and checked regularly for water proofing. Some sockets seen here are not waterproof.

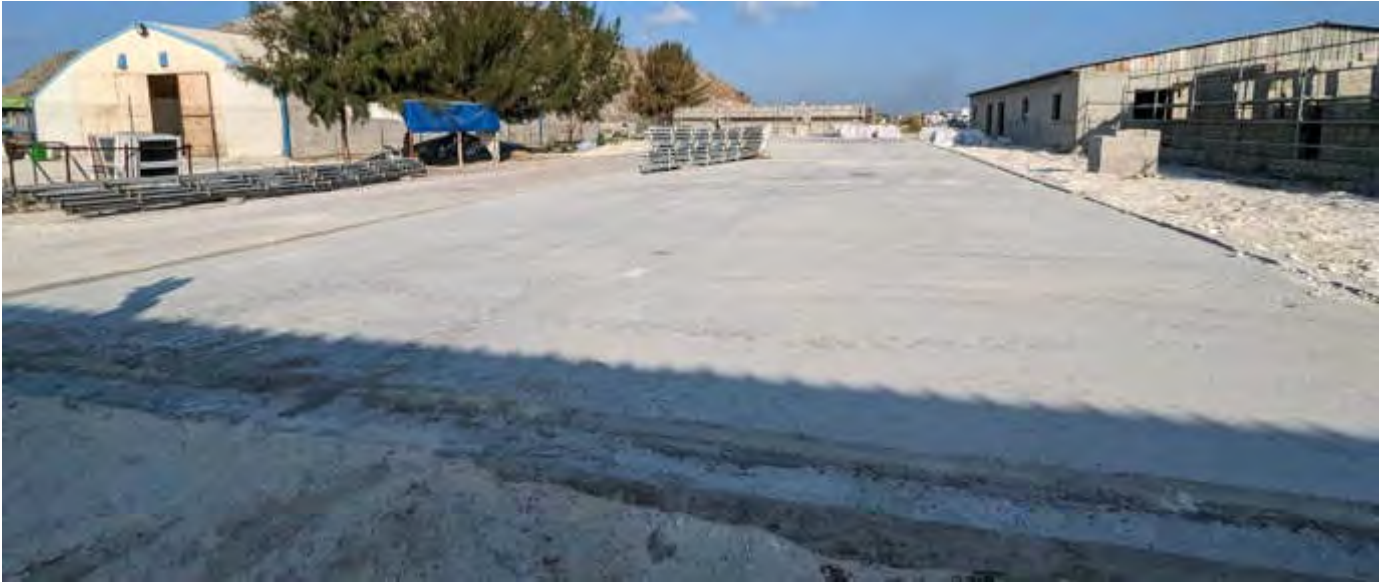
Photo 32 by Naif 27/02/23 16:45hrs

Foundations laid for workers accommodations, the prefab buildings are yet to be delivered to site.

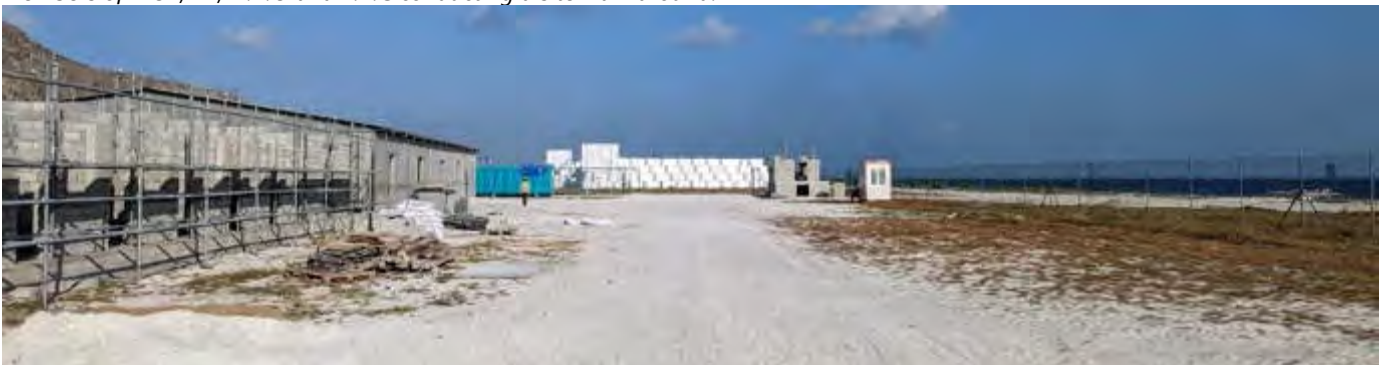
Photo 34 by Naif 27/02/23 16:55hrs

Workers accommodation building still under construction.

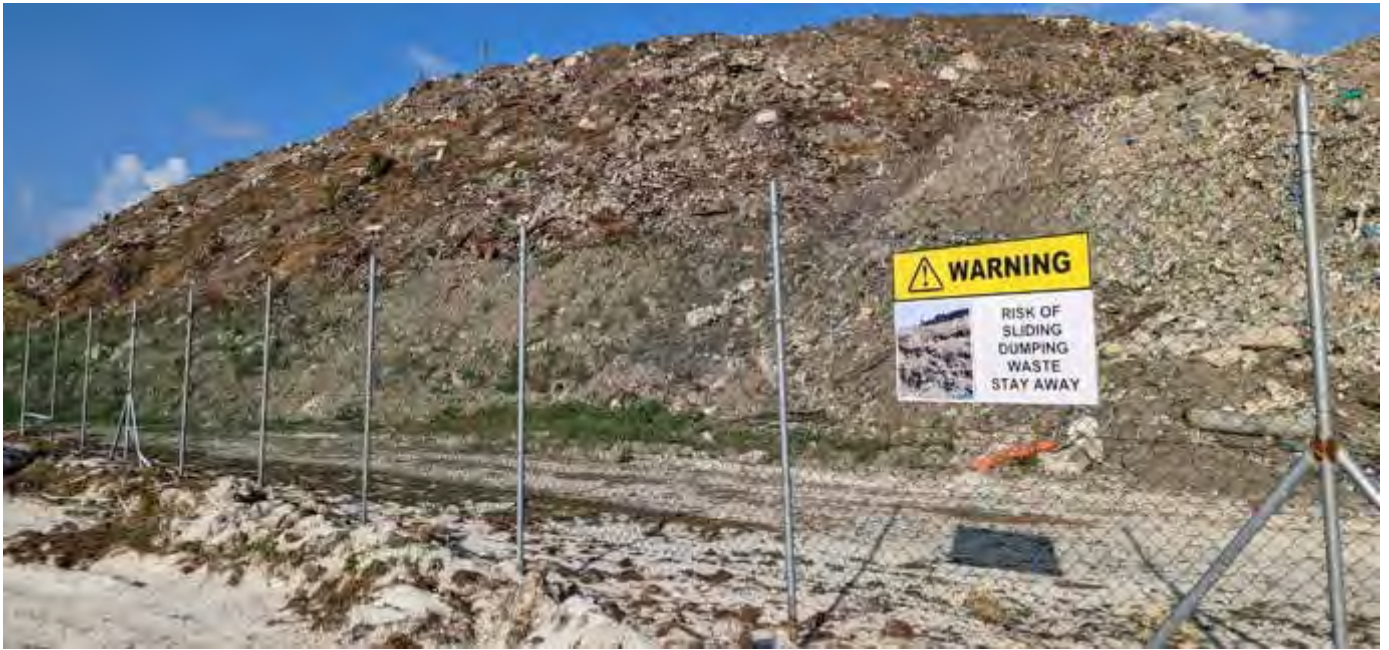
Photo 38 by Naif 27/02/23 17:03hrs.

Site boundary fence towards the WAMCO landfill area, has warning signs and work has been stopped at this side of the site.

No.	Particulars	Details / Remarks	Witnessed by	Reference
1	Fencing and Perimeter	Fencing works towards the WAMCO landfill on hold due to risk of working close to the WAMCO landfill still remains high.	Sathiyaraj Arunachalam – D.B.O	-
2	Site Preparation	Delays expected as several buildings still under construction, and the WWTP connections still remain incomplete. MWSC pump truck being used to pump out and dispose of the waste on a regularly basis. Survey Control points for the setting out of the plant and related buildings in place, the accuracy of these point shall be verified and survey reports should be submitted to the E.R.	Sathiyaraj Arunachalam – D.B.O	Photo 19
3	Temporary facilities	Work on the temporary facilities on going with average 50 workers. Several buildings still remain to be completed,	Sathiyaraj Arunachalam – D.B.O	Photo 1,4,5,7 to 19

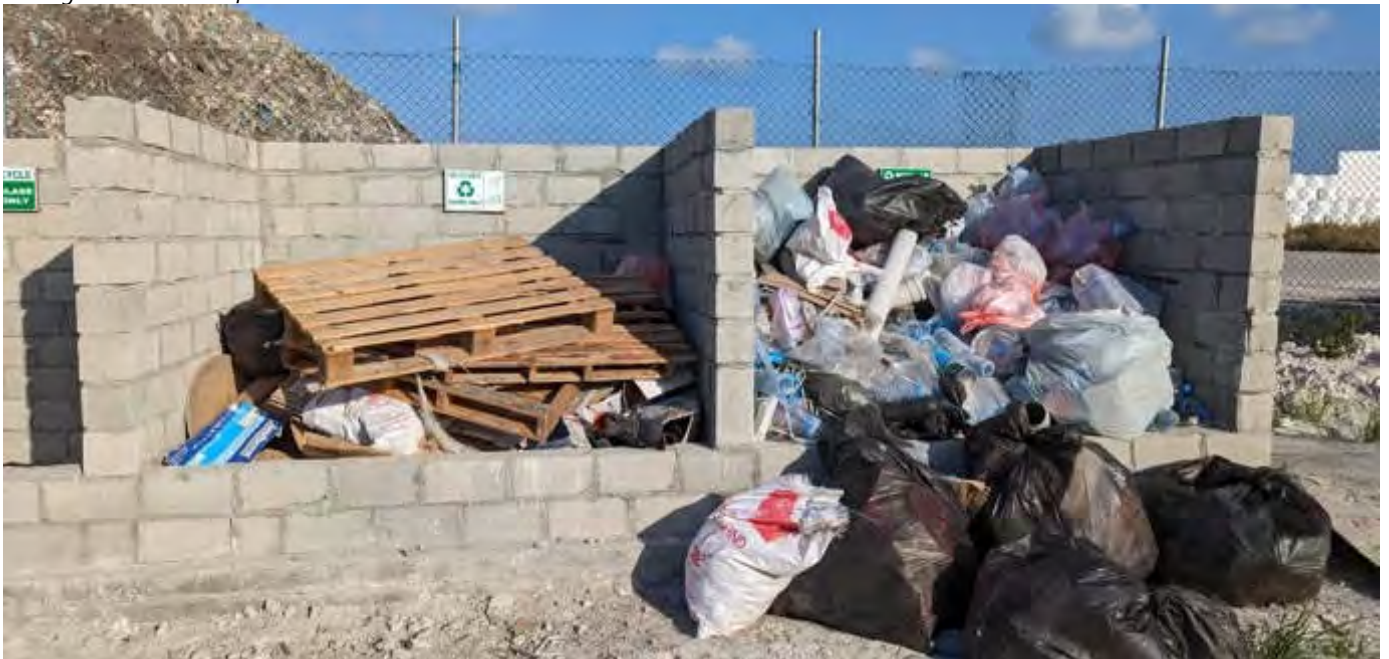
Photo 40 by Naif 27/02/23 17:16hrs .

Waste sorting and storage area established, requires a waste management plan to bbe developed and approved.

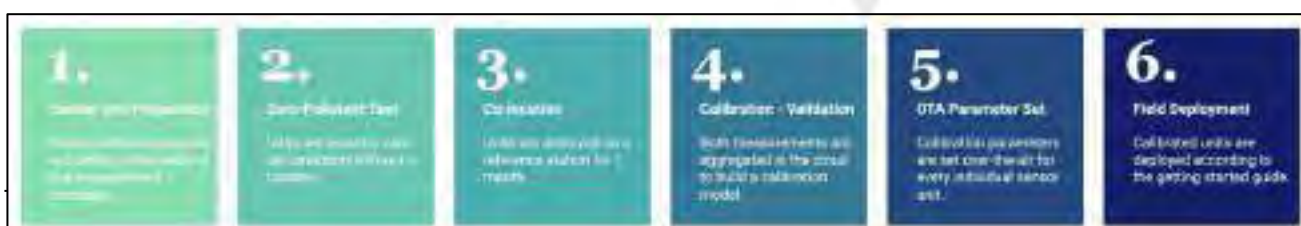
The accuracy of these low-cost sensors is as critical as measuring the air quality. With the smart calibration process, low-cost sensors are corrected and accurate compared to reference stations. The Smart Calibration Algorithm consists of the below operational steps shown figure below.

Sensor Units were calibrated using reference stations for a period before the deployment. The calibration process for particle matter and gas pollutants measurement is explained below.

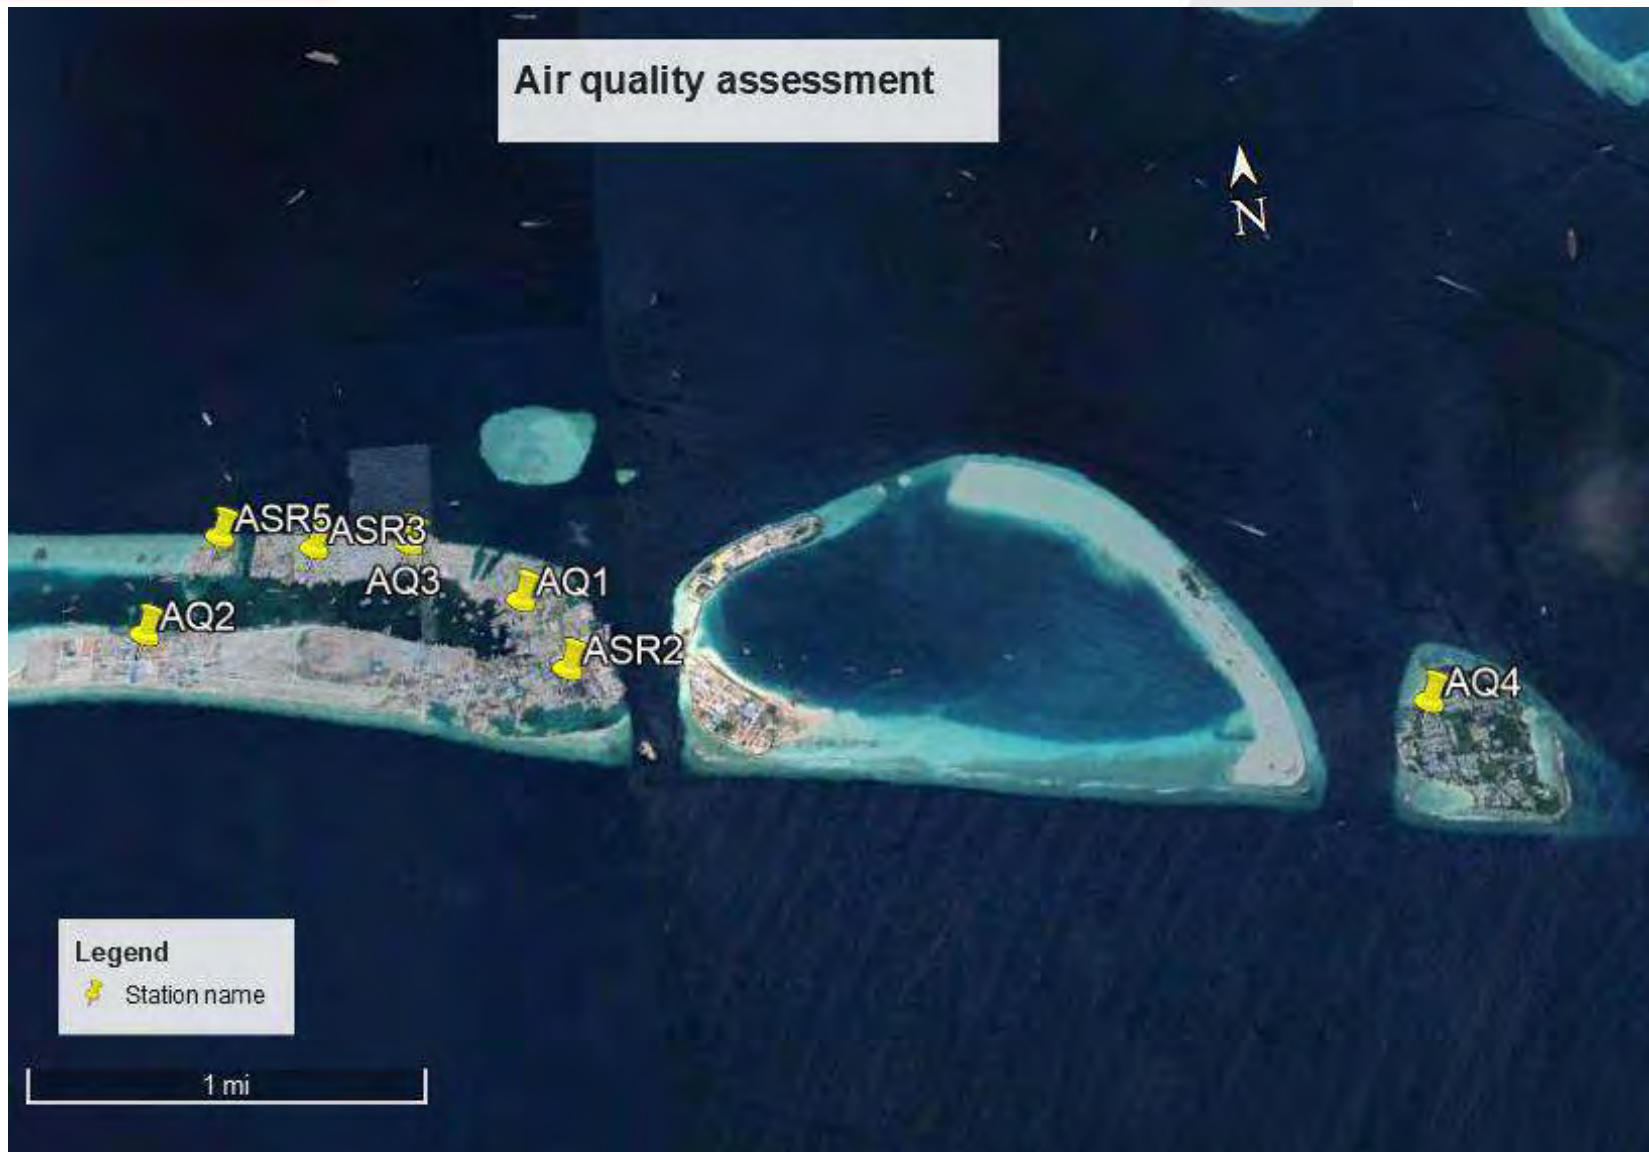
Figure 1 Sampling Points on satellite Map

For the Preconstruction baseline environmental assessment of the ambient air quality was conducted at seven locations: 6 locations at Thilafushi (AQ1, AQ2, and AQ3 in the EIA and the ASR 2, ASR3 and ASR5 recommended for monitoring in the EIA Report) and one location at Villingili (AQ4).

No	Location	Description	Distance to Source (meters)
1	AQ1	Represents dense industrial area	650
2	AQ2	Represents dense industrial area	1000
3	AQ3	Represents dense industrial area	500
4	ASR2	Represents dense industrial area	700
5	ASR3	Represents dense industrial area	500
6	ASR5	Represents dense industrial area	1000
7	AQ4	Represents dense housing and population area	4500

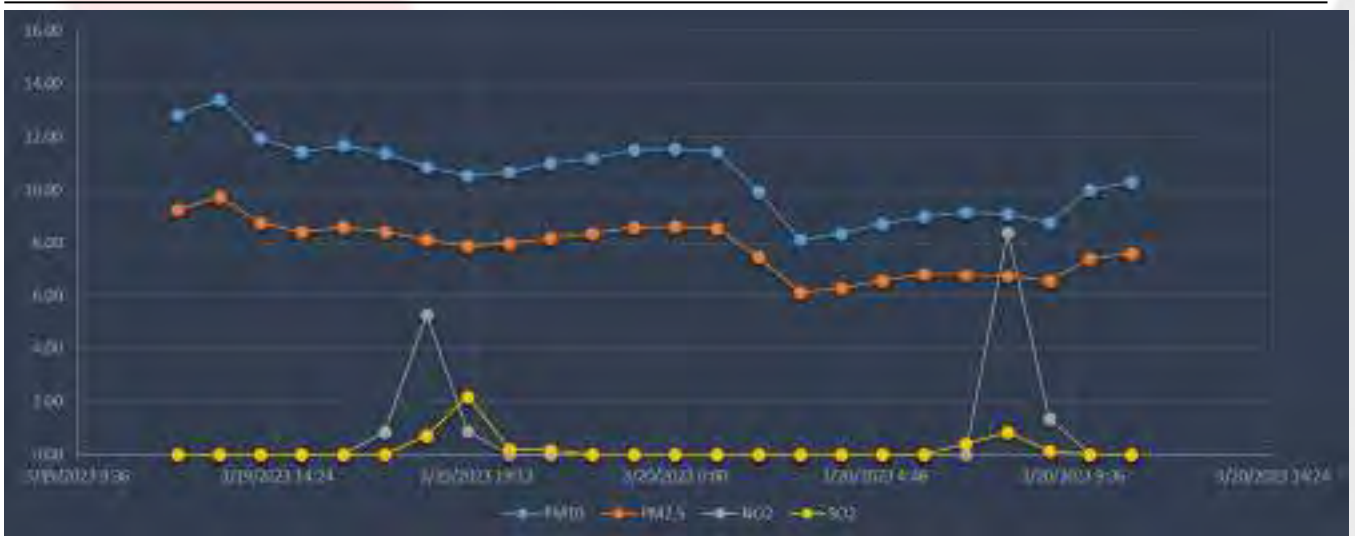
Figure 3 Measurement Graphs for Location AQ2

Location	Sampling Date	Results ($\mu\text{g}/\text{m}^3$)					Ambient Conditions	
		PM ₁₀	PM _{2.5}	NO ₂	SO ₂	TSP (24 Hours Average)	Humidity (%)	Temperature (°C)
AQ2	2023-3-19 12:00:00	12.81	9.25	0	0	36.27	62.24	30.52
	2023-3-19 13:00:00	13.40	9.74	0	0	37.24	62.83	30.47
	2023-3-19 14:00:00	11.93	8.75	0	0	33.50	54.56	29.43
	2023-3-19 15:00:00	11.44	8.42	0	0	32.15	51.30	29.01
	2023-3-19 16:00:00	11.67	8.61	0	0	32.53	51.16	29.09
	2023-3-19 17:00:00	11.37	8.43	0.85	0	31.74	51.90	28.70
	2023-3-19 18:00:00	10.88	8.11	5.28	0.7	30.40	53.64	28.23
	2023-3-19 19:00:00	10.53	7.88	0.89	2.18	29.36	55.69	27.45
	2023-3-19 20:00:00	10.68	7.98	0	0.22	29.76	62.98	27.20
	2023-3-19 21:00:00	10.99	8.20	0	0.18	30.65	67.77	27.94
	2023-3-19 22:00:00	11.18	8.36	0	0	31.30	69.61	27.53
	2023-3-19 23:00:00	11.51	8.60	0	0	32.27	69.96	26.36
	2023-3-20 00:00:00	11.52	8.61	0	0	32.43	70.86	26.22
	2023-3-20 01:00:00	11.44	8.55	0	0	32.34	71.42	26.13

2023-3-20 02:00:00	9.94	7.47	0	0	28.16	84.97	26.26
	2023-3-20 03:00:00	8.12	6.12	0	0	22.65	83.79	26.15
	2023-3-20 04:00:00	8.35	6.26	0	0	23.27	84.64	25.94
	2023-3-20 05:00:00	8.72	6.54	0	0	24.40	85.52	25.83
	2023-3-20 06:00:00	9.01	6.81	0	0	25.49	84.75	25.74
	2023-3-20 07:00:00	9.16	6.79	0	0.41	26.13	85.33	26.65
	2023-3-20 08:00:00	9.08	6.76	8.4	0.86	25.85	85.24	27.66
	2023-3-20 09:00:00	8.77	6.55	1.36	0.14	24.69	83.59	27.20
2023-3-20 10:00:00	9.99	7.41	0	0	27.99	72.35	28.23	
2023-3-20 11:00:00	10.30	7.63	0	0	29.19	64.32	29.74	
Hourly Limit Values	TA Luft	-	-	200	350	-	-	-
	EU	-	-	200	350	-	-	-
	WHO Ambient Air Quality Guideline Value	-	-	-	-	-	-	-
Average		10.53	7.83	0.70	0.20	29.57	69.60	27.65
Daily Limit Values	TA Luft	50	-	-	125	-	-	-
	EU	50	-	-	125	-	-	-
	WHO Ambient Air Quality Guideline Value	45	15	25	40	-	-	-

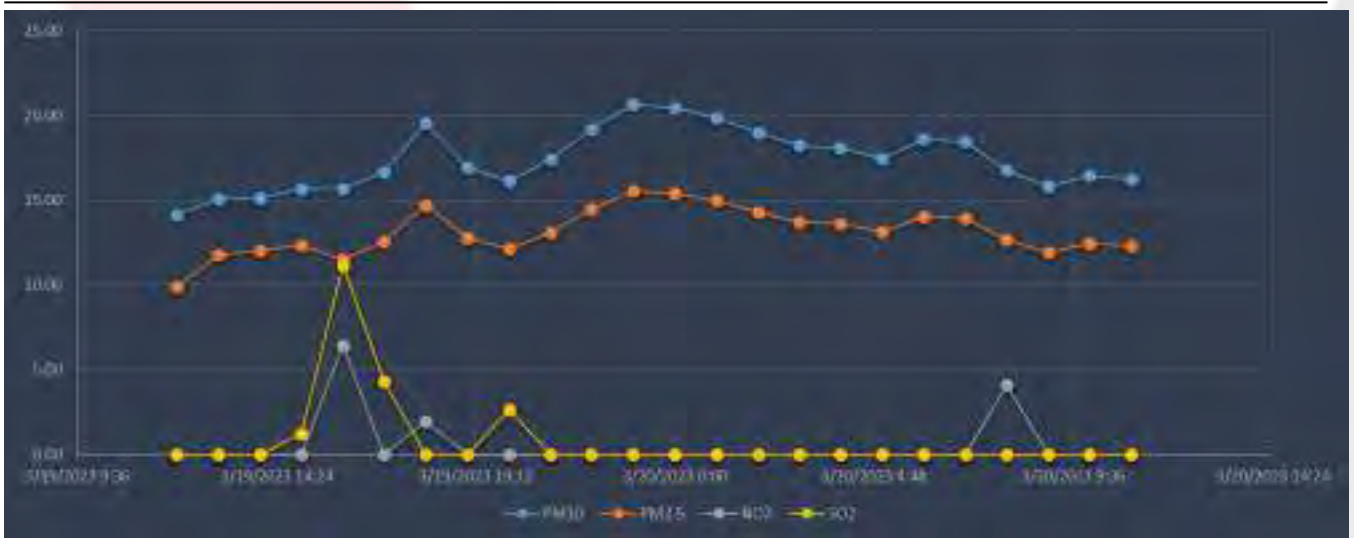
Figure 5 Measurement Graphs for Location ASR2

Location	Sampling Date	Results (µg/m ³)					Ambient Conditions	
		PM ₁₀	PM _{2.5}	NO ₂	SO ₂	TSP (24 Hours Average)	Humidity (%)	Temperature (°C)
ASR2	2023-3-19 12:00:00	14.18	9.85	0	0	37.69	67.53	29.98
	2023-3-19 13:00:00	15.12	11.80	0	0	40.74	70.19	29.21
	2023-3-19 14:00:00	15.13	12.04	0	0	40.07	68.61	28.03
	2023-3-19 15:00:00	15.66	12.40	0	1.24	41.14	67.70	27.97
	2023-3-19 16:00:00	15.67	11.56	6.41	11.18	41.53	68.40	27.83
	2023-3-19 17:00:00	16.65	12.58	0	4.32	43.74	68.89	27.59
	2023-3-19 18:00:00	19.53	14.74	1.96	0	50.40	69.81	27.24
	2023-3-19 19:00:00	16.94	12.79	0	0	44.22	71.62	26.81
	2023-3-19 20:00:00	16.13	12.19	0	2.61	42.38	75.94	25.55
	2023-3-19 21:00:00	17.38	13.11	0	0	45.40	78.59	24.73
	2023-3-19 22:00:00	19.21	14.46	0	0	49.70	80.50	24.41
	2023-3-19 23:00:00	20.64	15.55	0	0	53.18	80.50	24.30
	2023-3-20 00:00:00	20.43	15.40	0	0	52.62	81.69	24.20
	2023-3-20 01:00:00	19.88	14.98	0	0	51.19	82.06	24.15

2023-3-20 02:00:00	18.96	14.29	0	0	48.49	84.71	25.46
	2023-3-20 03:00:00	18.23	13.73	0	0	46.39	81.07	26.38
	2023-3-20 04:00:00	18.10	13.65	0	0	46.14	79.21	26.82
	2023-3-20 05:00:00	17.44	13.18	0	0	44.69	80.64	26.49
	2023-3-20 06:00:00	18.59	14.05	0	0	47.39	79.67	26.67
	2023-3-20 07:00:00	18.47	13.94	0	0	46.82	76.78	27.61
	2023-3-20 08:00:00	16.80	12.71	4.08	0	42.93	76.54	27.58
	2023-3-20 09:00:00	15.82	11.97	0	0	40.75	76.33	27.60
	2023-3-20 10:00:00	16.45	12.47	0	0	42.71	71.23	28.92
2023-3-20 11:00:00	16.26	12.32	0	0	42.10	65.23	30.49	
Hourly Limit Values	TA Luft	-	-	200	350	-	-	-
	EU	-	-	200	350	-	-	-
	WHO Ambient Air Quality Guideline Value	-	-	-	-	-	-	-
Average		17.40	13.16	0.52	0.81	45.10	75.14	26.92
Daily Limit Values	TA Luft	50	-	-	125	-	-	-
	EU	50	-	-	125	-	-	-
	WHO Ambient Air Quality Guideline Value	45	15	25	40	-	-	-

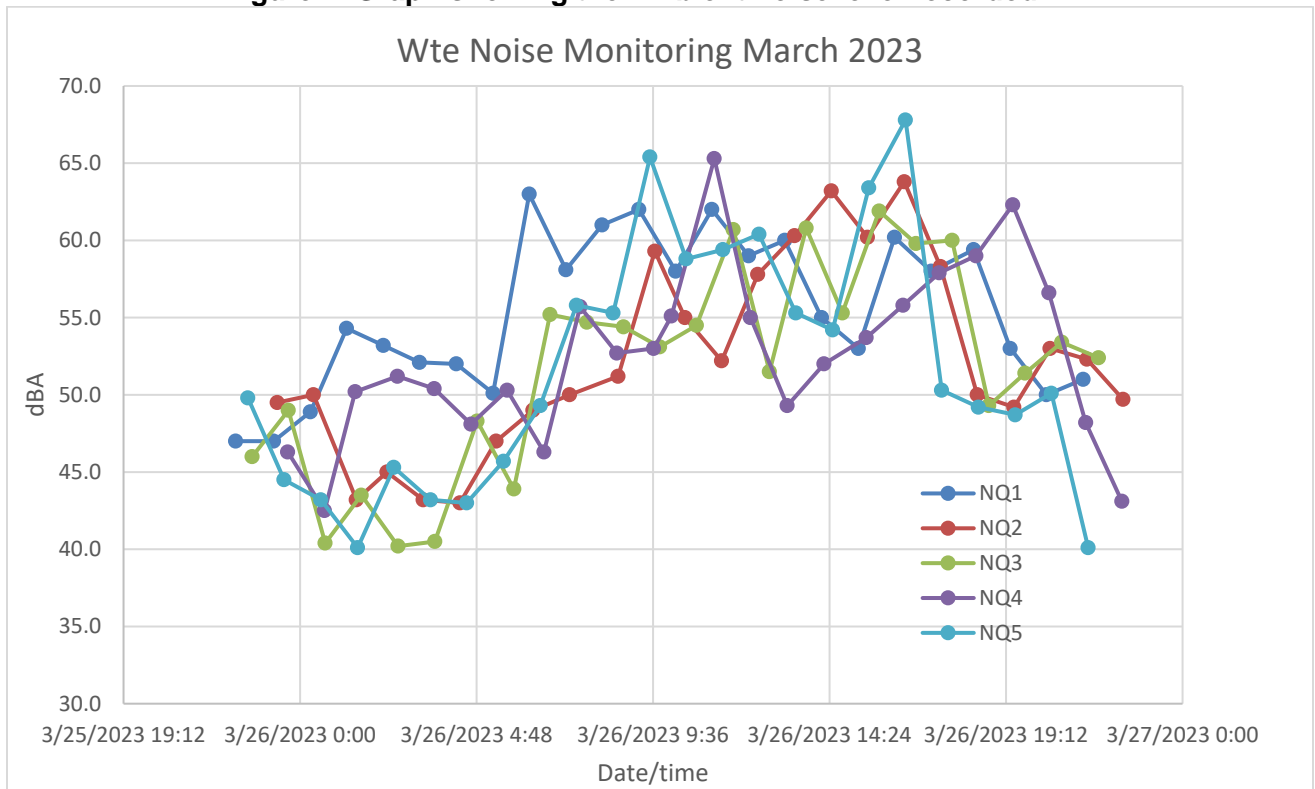
Figure 2. Graph showing the Ambient noise level recorded

There are no designated national standards for ambient noise level in outdoor industrial area in the Maldives. Compared to WHO and ADB specified noise level standards for outdoors industrial and commercial area the noise level in Thilafushi island and the subproject area is below the noise level standards. The results show that in all the stations ambient noise level are below threshold levels specified by the WHO standards.

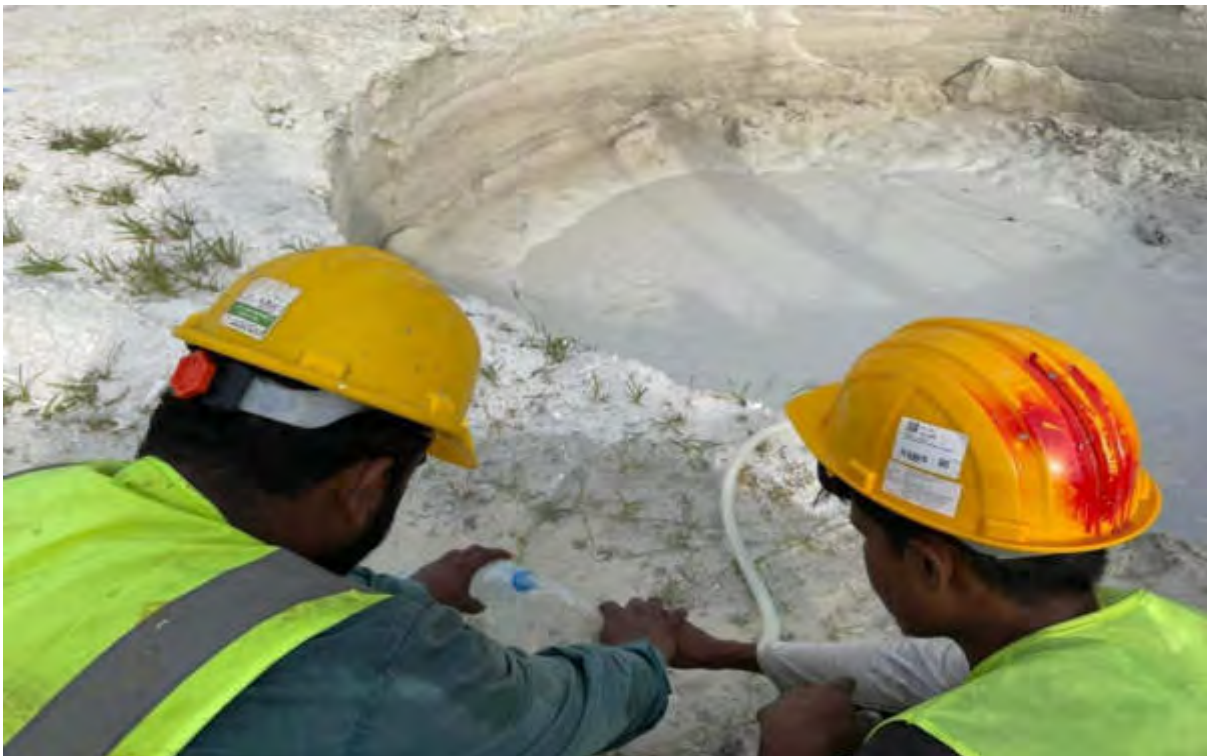
Ground water samples have been collected for dewatering permit.

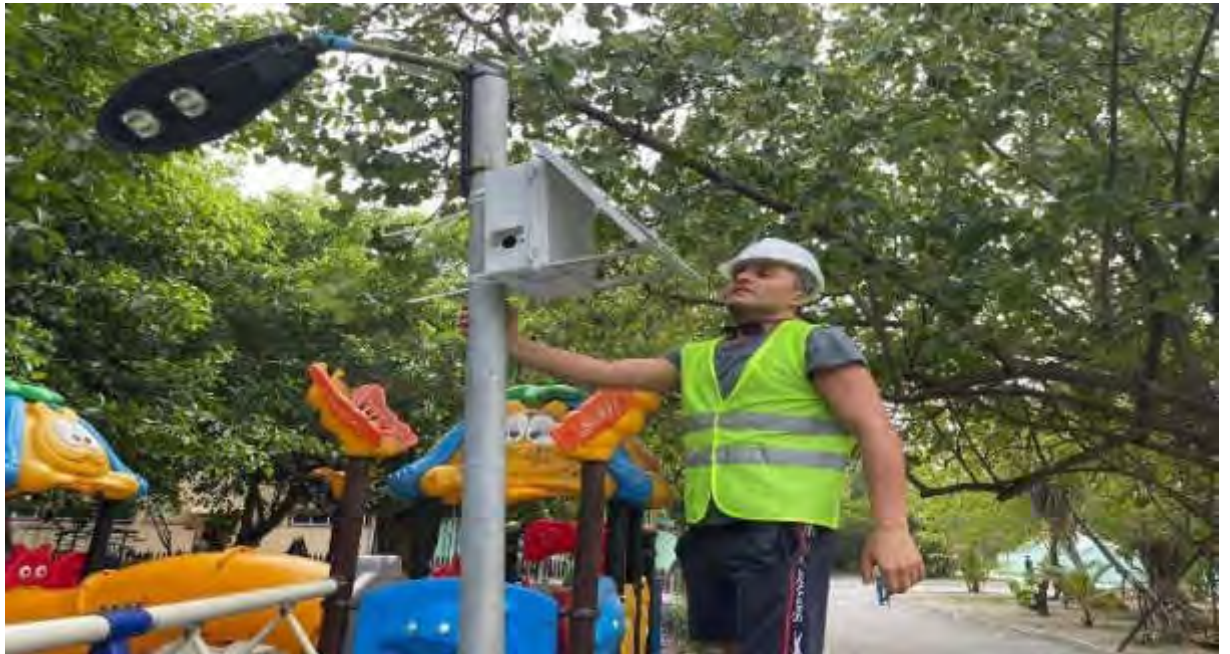
Ambient Air monitoring

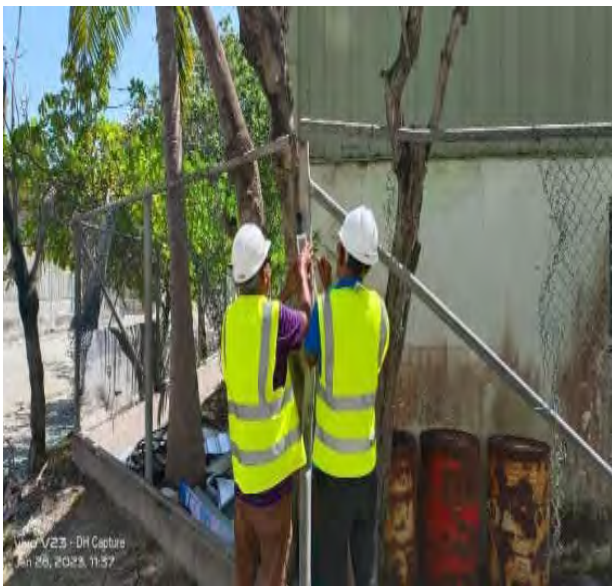
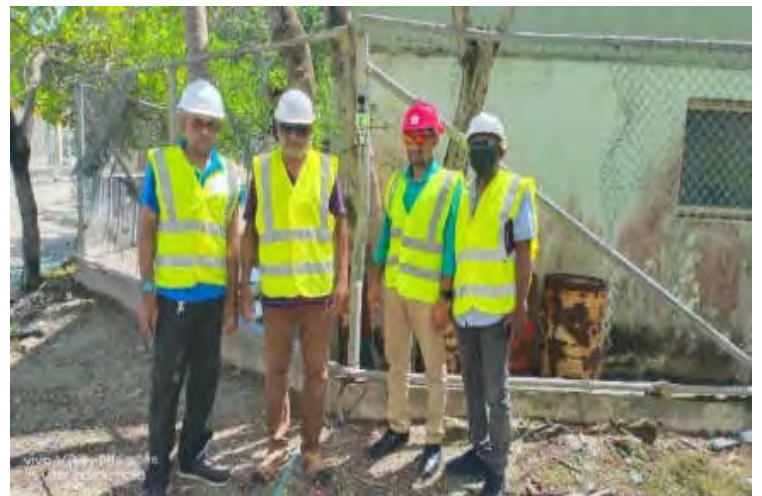
Noise Level Monitoring for Pre-Construction Monitoring.

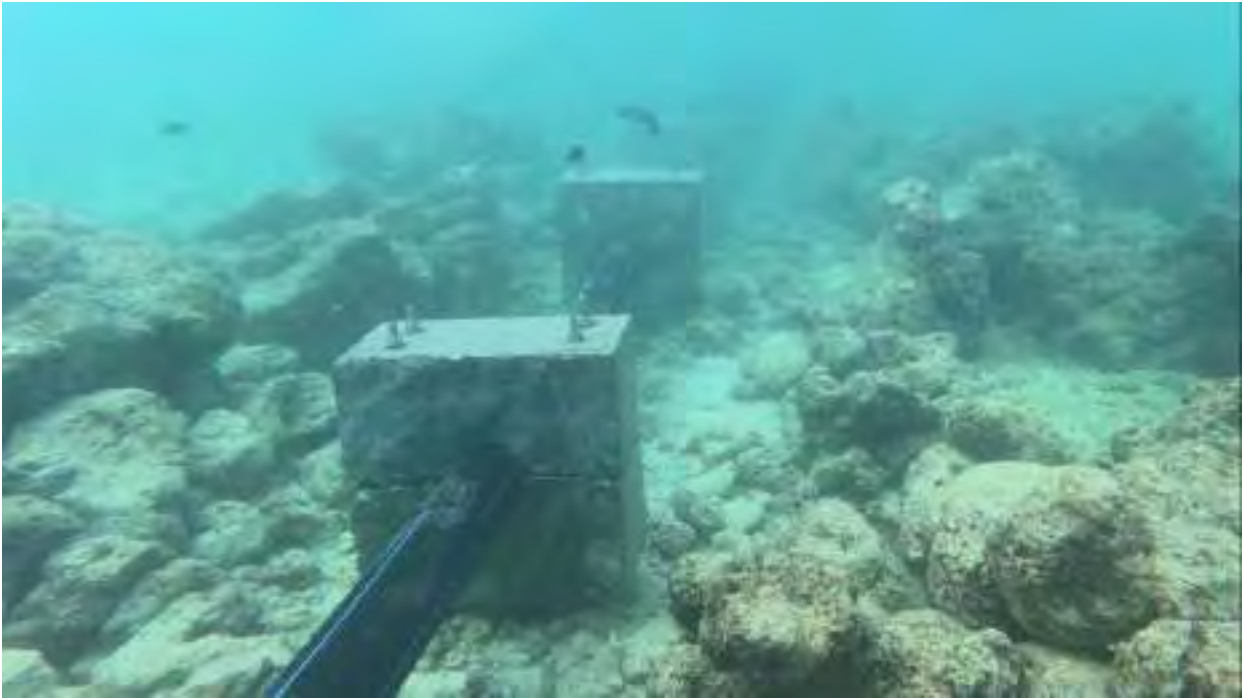
Outfall Pipeline installation to discharging sewage from WWTP to the sea was completed.

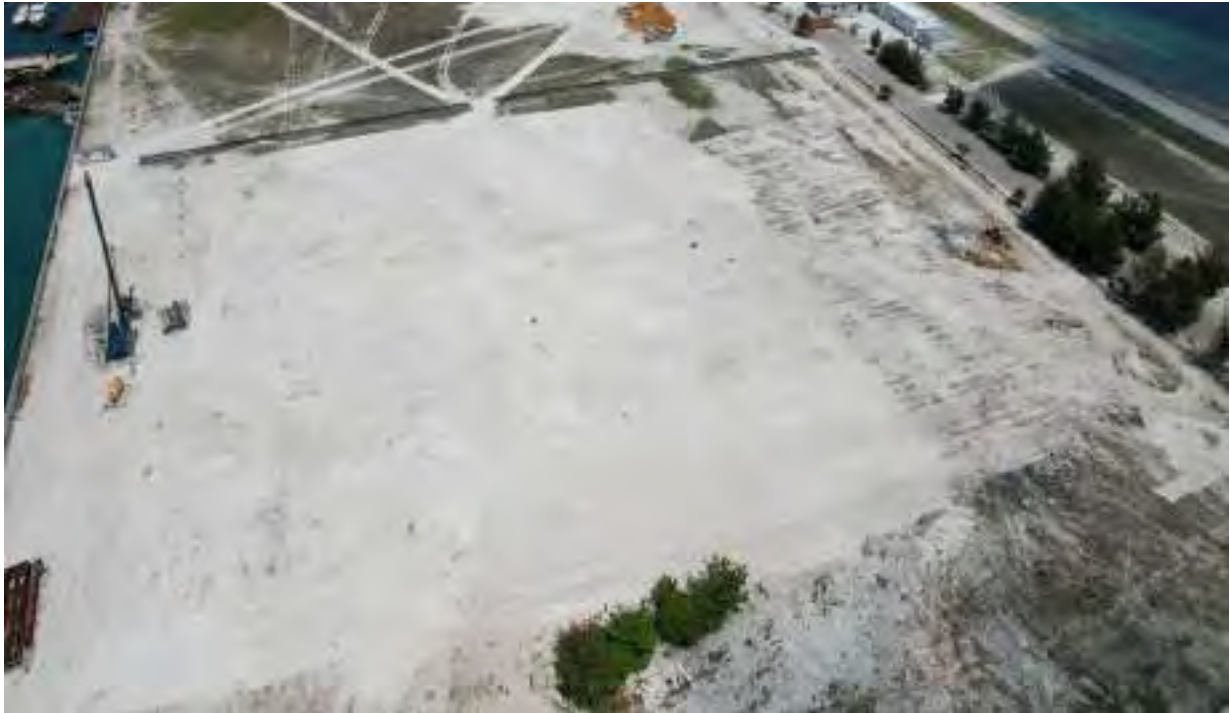
Stripping of the site by removing the vegetation of the site to be prepared for the piling activity is ongoing.
