Environmental Monitoring Report

Project Number: 51077-003
Quarterly Report (January to March 2023)
June 2023

Maldives: Greater Male Waste-to-Energy Project

Prepared by the Ministry of Environment, Climate Change and Technology for the Ministry of Finance for the Asian Development Bank.

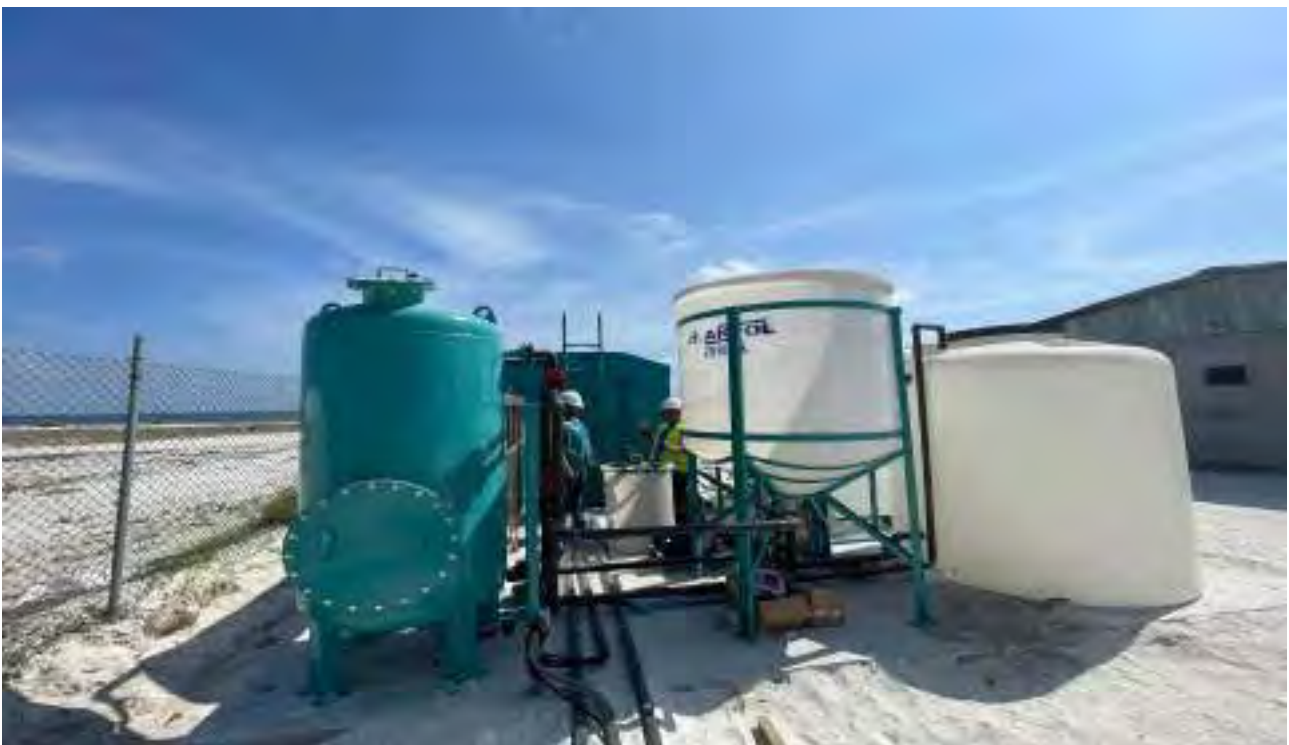
Installation of the WWTP was completed
