# Environmental and Social Impact Assessment Report

Upgrading of infrastructure at Regional Waste  
Management Facility Zone II, Raa, Vandhoo

Ministry of Environment

January 2019

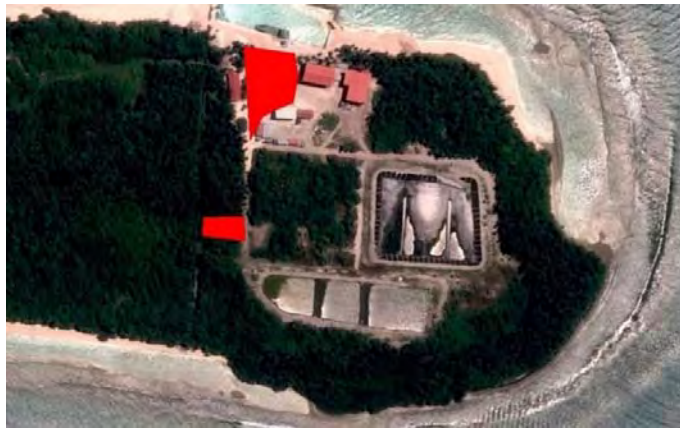
Figure 6. Recommended areas for temporary material storage

Construction material for the project, such as building material, galvanized iron pipes and nets will be brought to the island on bigger vessels. Materials will be unloaded to the island at the existing harbor. Construction materials will be temporarily stored at the areas indicated on Figure 6 below as these areas are currently barren. Vegetation clearance for temporary storage is not recommended. Once the land gets cleared for building plots, some material can be moved about to those areas as well.

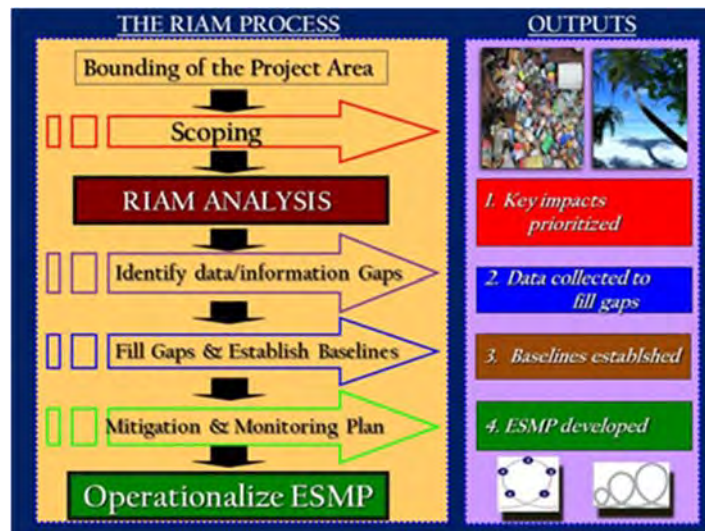
Figure 10. Diagram showing the RIAM process

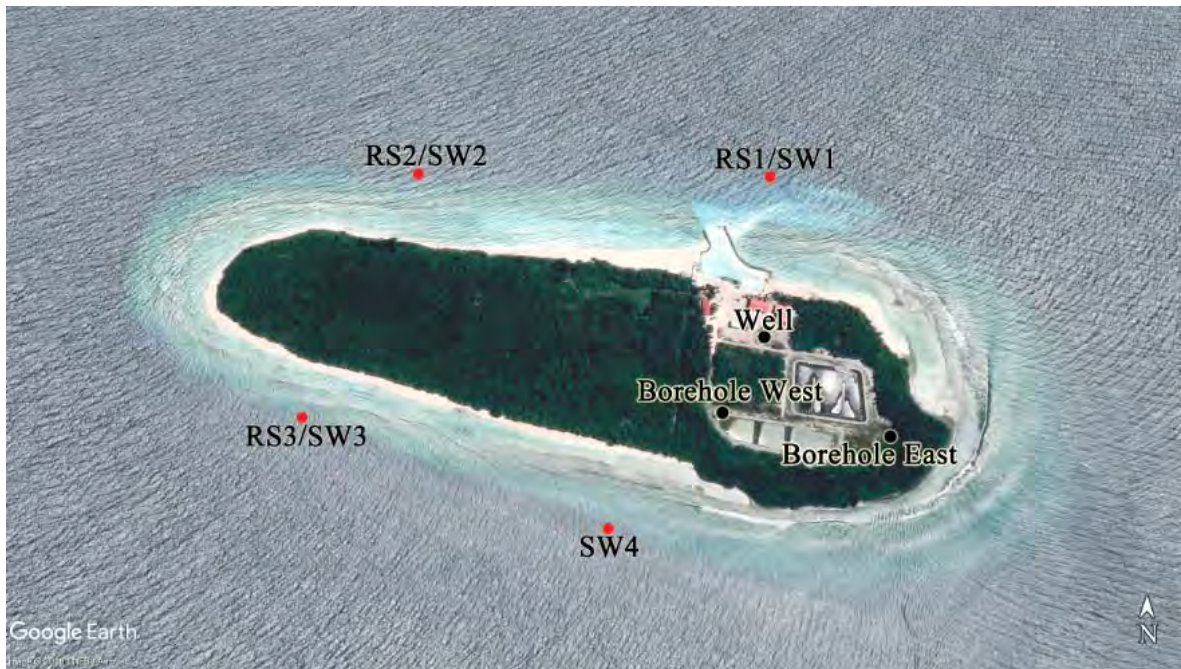
**Figure 14. Reef survey and water sampling sites at Vandhoo**

Reef fish abundance and diversity was assessed along the same belt the reef survey was done, at a depth of 2-3m. The assessment was generally made at the family level, with the focus on estimating the presence of major fish groups and predominant species.

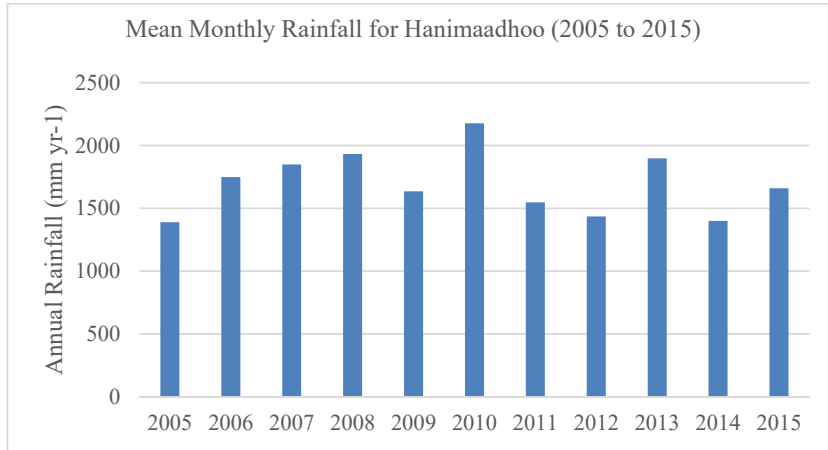
**Figure 17. Rainfall pattern for Hanimaadhoo Meteorological Centre (rainfall data provided by Maldives Meteorological Centre)**

Vandhoo is located in the northern region where the average rainfall tends to be less than southern regions of Maldives. This is corroborated by the weather records from the closest weather station, Hanimaadhoo and weather station in the South, S. Gan. Rainfall records indicate that the average annual rainfall is 1697.3 mm (Standard deviation of 251.0 mm) and mean monthly rainfall is 141.4 mm (Figure 17).

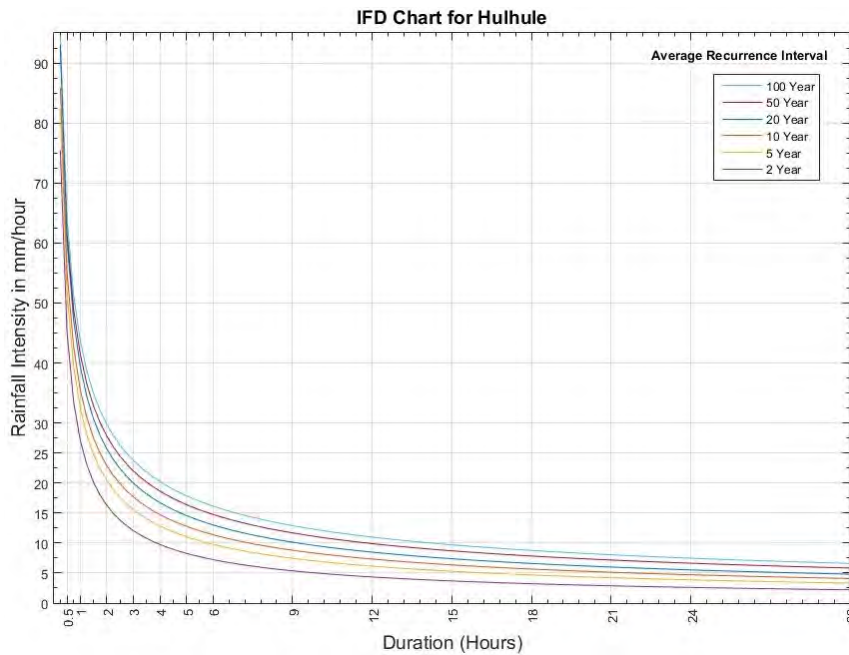
**Figure 18. IFD chart for Hulhule (source: Riyan Pvt Ltd, 2017)**

Intensity Frequency Duration (IFD) Curves was derived from data provided by meteorological department for the period August 2013 to February 2017 (Figure 18). In addition to this, three-hour rainfall data from January 2005 to July 2013 were also used.

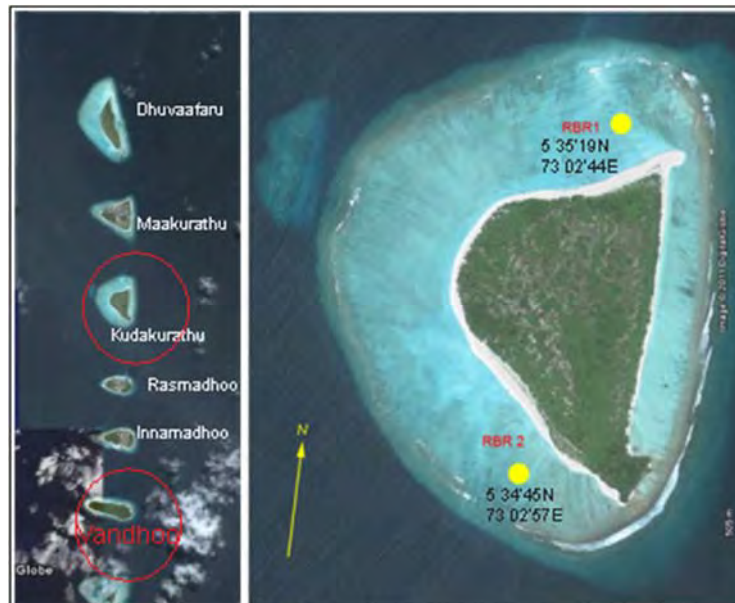
**Figure 20. Location of Kudakurathu with respect to Vandhoo and location of wave gauges**

Since site specific wave data is not available for Vandhoo; data collected at a nearby island (located at the eastern periphery as Vandhoo) was used to understand the wave climate of the area. The island of Kudakurathu is proposed for resort development and as part of Environmental data collection; LaMer Pvt Ltd has collected wave and tide data from this island. The island of Kudakurathu is approximately 4.7 km north of Vandhoo (Figure 20 shows location of Kudakurathu and wave gauge). RBR model TWR 2050 was used to collect wave data at 30 min interval burst.

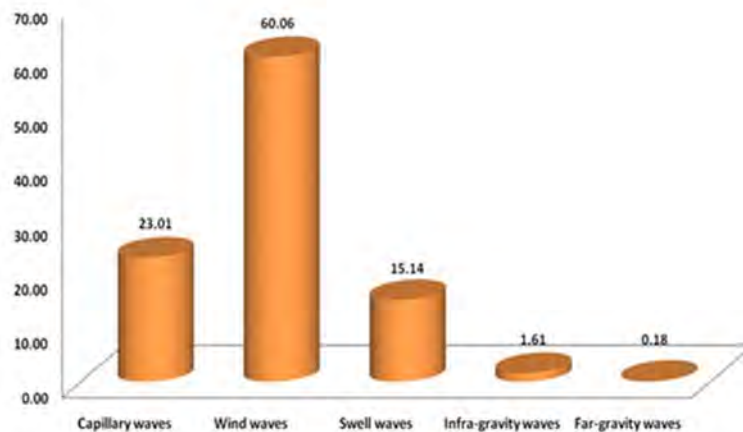
Figure 21. Types of waves observed on the northern side

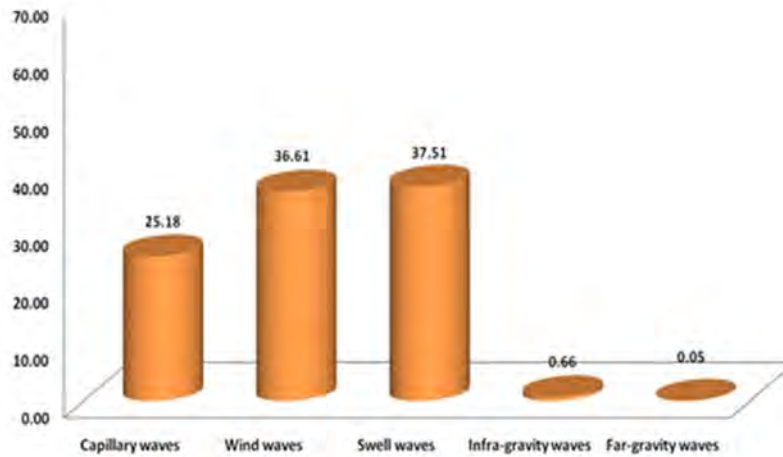
**Figure 22. Types of waves observed on the southern side**

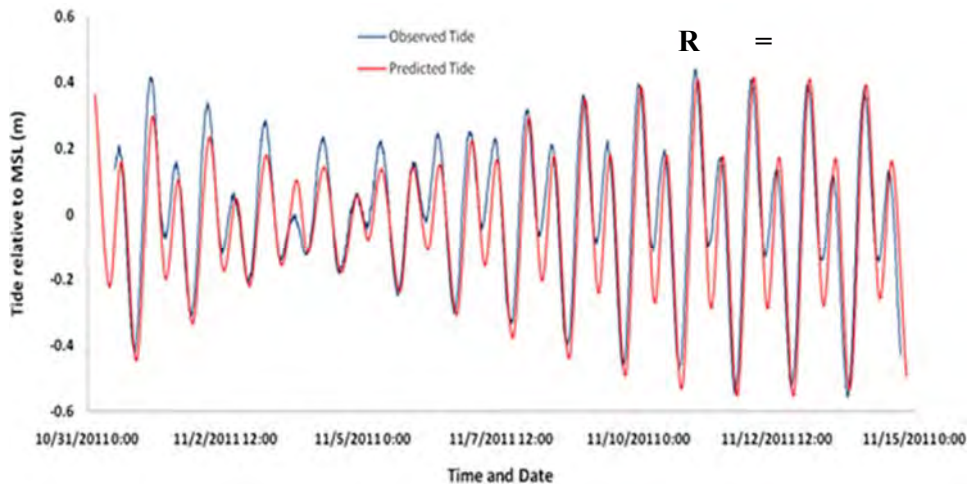
Figure 24. Tide measured by the tide gauge and the superimposed predicted tide

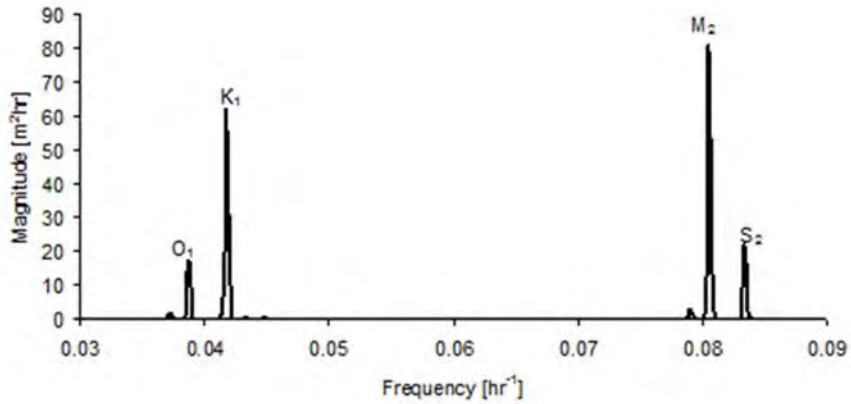
Figure 25. Spectral density for the tide of Hanimaadhoo

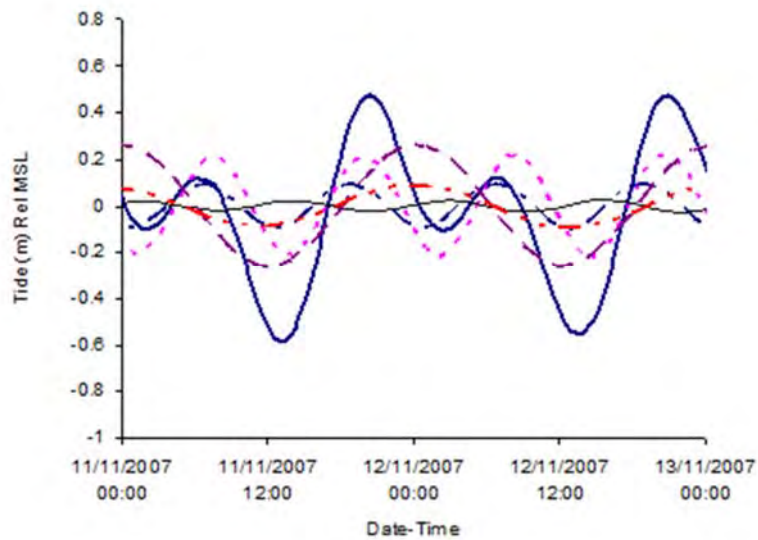
Figure 26. Time series plot of the dominant constituents of the tide at Hanimaadhoo showing the significance of each of these constituents in the tidal signal

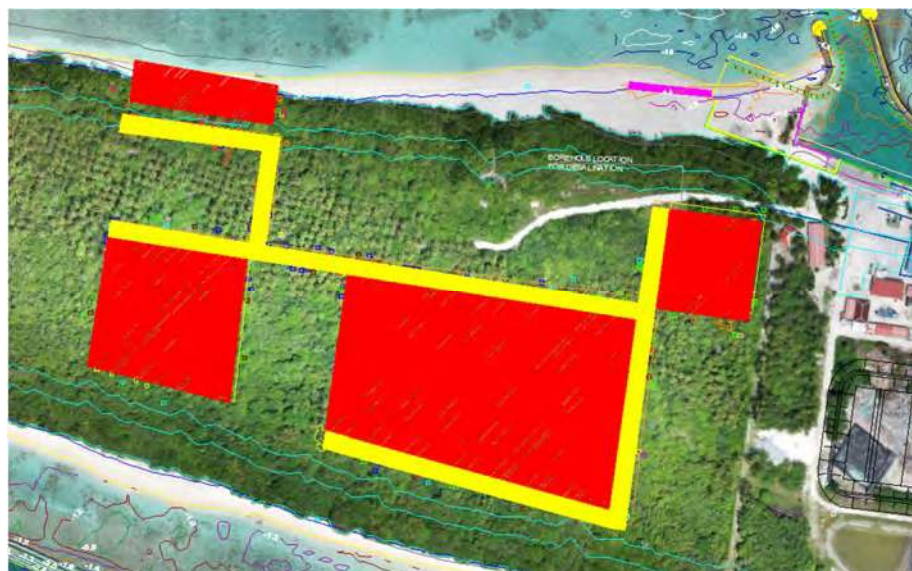
**Figure 33. Areas which require vegetation clearance to develop the plots (red) and roads (yellow) as per the proposed master plan**

Vegetation survey shows that a thick coconut grove exists at the areas proposed for most development plots. Island vegetation consists of plant typically found in Maldivian soil. Table 14 below shows the number and names of plants required to be cleared from the footprint areas. It is estimated that about 18.5 % of vegetation will need to be cleared from the existing vegetation. Building / road footprint areas which require vegetation clearance to develop the plots and roads as per the proposed masterplan are indicated on Figure 33.

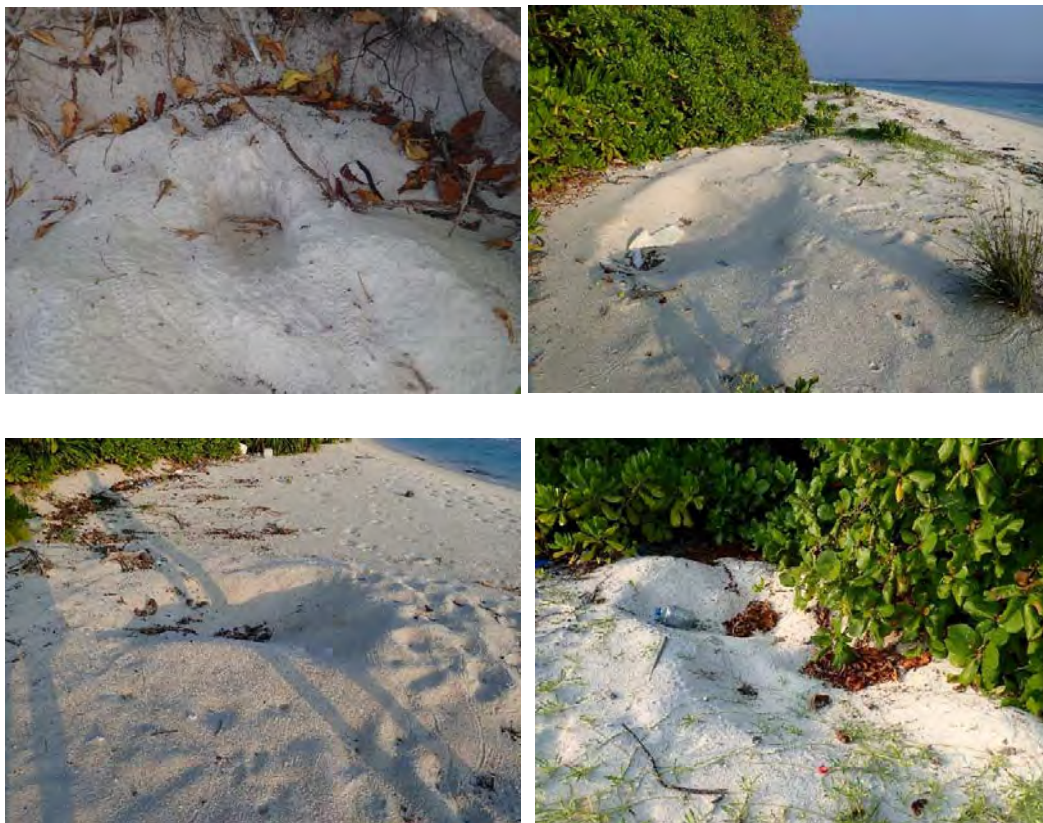
**Figure 34. Evidence of turtle nesting pits observed at Vandhoo**

Since Vandhoo is identified as a turtle nesting site, evidence of turtle nesting sites was assessed by walking on the beach and visually inspecting the beach for signs such as nesting pits and turtle crawls. As such, about 4 turtle nesting pits were observed during the site visit in November 2018. Absence of tracks at these pits indicated that the pits were about few weeks to few months old. Human exploitation was observed at all 4 pits. The nesting pits were not necessarily confined to the turtle conservation area identified in the Masterplan (Appendix 4), but rather, the nesting pits were observed all around the island.

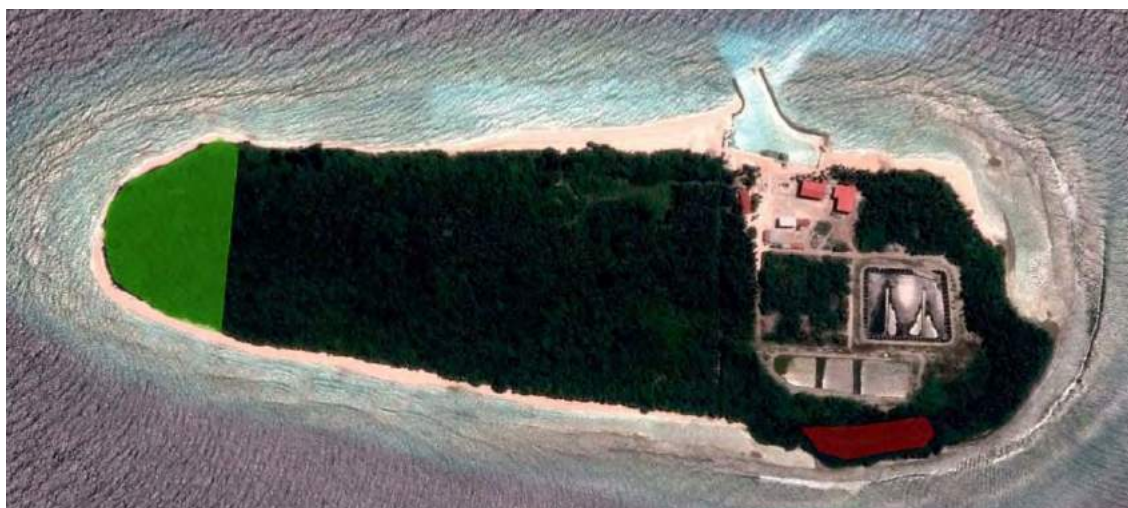
**Figure 40. Area with mangrove (red highlight) and turtle conservation area (green highlight).**

A small mangrove area exists at the southeastern periphery of the island just below the leachate ponds (Figure 40). This area is preserved and no development activities will reach this area. Moreover, an area of about 42,400 m<sup>2</sup> at the western tip (Figure 40) of the island is preserved for turtle conservation under this project, however, turtle nesting is not necessarily confined to the area marked as a turtle conservation area on Figure 40. Vandhoo was reportedly a nesting site for hawksbill turtles (*Eretmochelys imbricata*) (Riyan and NIRAS, 2012).

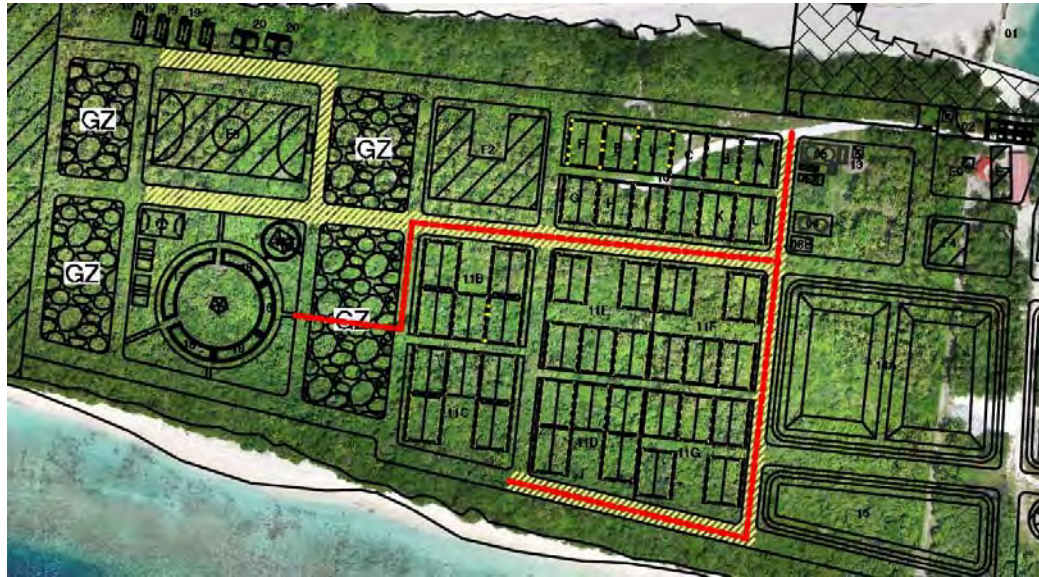
**Proposed road network:** Highlighted in yellow in Figure 43.

**Alternate road network:** Indicated in magenta in Figure 43.

**Figure 43. Proposed road network (yellow highlight) and alternate road network (red) for RWMF at Vandhoo**

***Selected road network:** a total of 17.7% of vegetation clearance is required for all building footprint area and road development. Approximately 19.5% of this area is contributed to by the area to be cleared for road development (which encompasses a total of 188 significant trees and coconut palms). Thus the Consultant feels that an alternate route which requires less vegetation clearance would be more feasible in terms of environmental impacts. Alternate route for road development (with width 10m) is given in Figure 43 and total area which requires to be cleared for proposed development with this route is approximately 16.6%, while 14% of this total is accounted for by road clearance (Approximate number of significant vegetation required to be cleared is 60). Furthermore, the proposed route provides access to guest blocks to be developed on the beach side, which as discussed in Section 8.1.3 are considered unnecessary and thus there is no reason to develop roads providing access to the area. Hence based on the area of clearance required, the Consultant considers the alternative route to be feasible and is selected for in the report. Table 28 compares the vegetation clearance required for the proposed road network with that of the alternative network.*

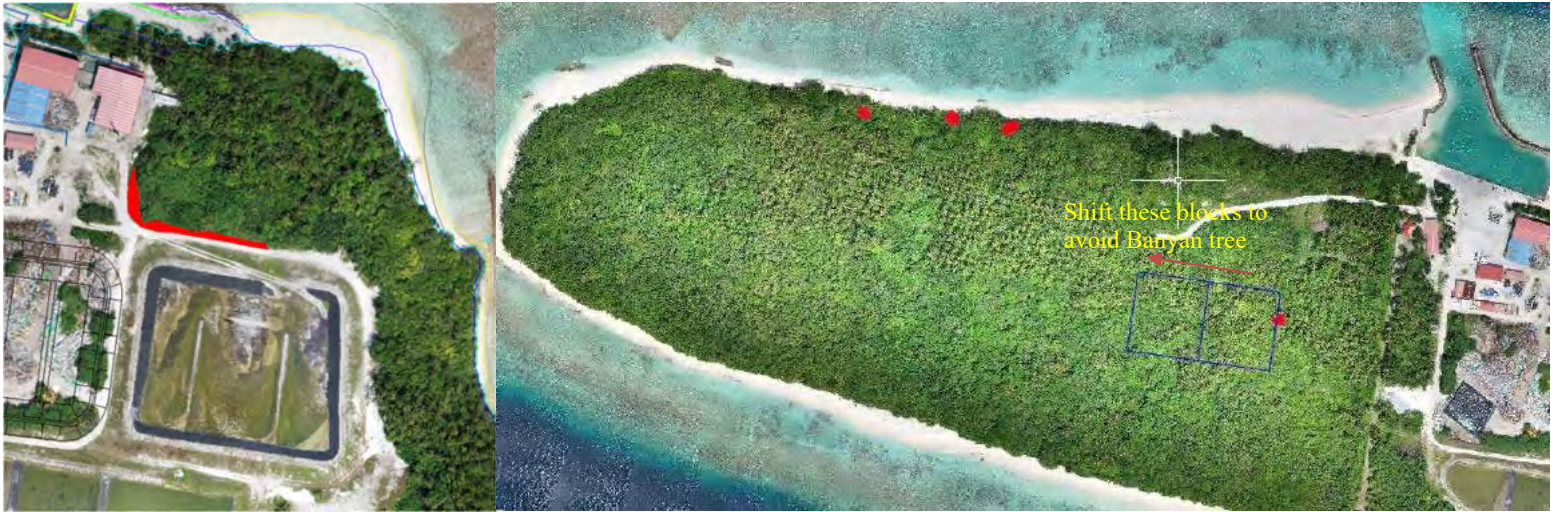
**Figure 44. Area proposed for relocation of some of the removed coconut palms (left). Locations of Banyan trees (right).**

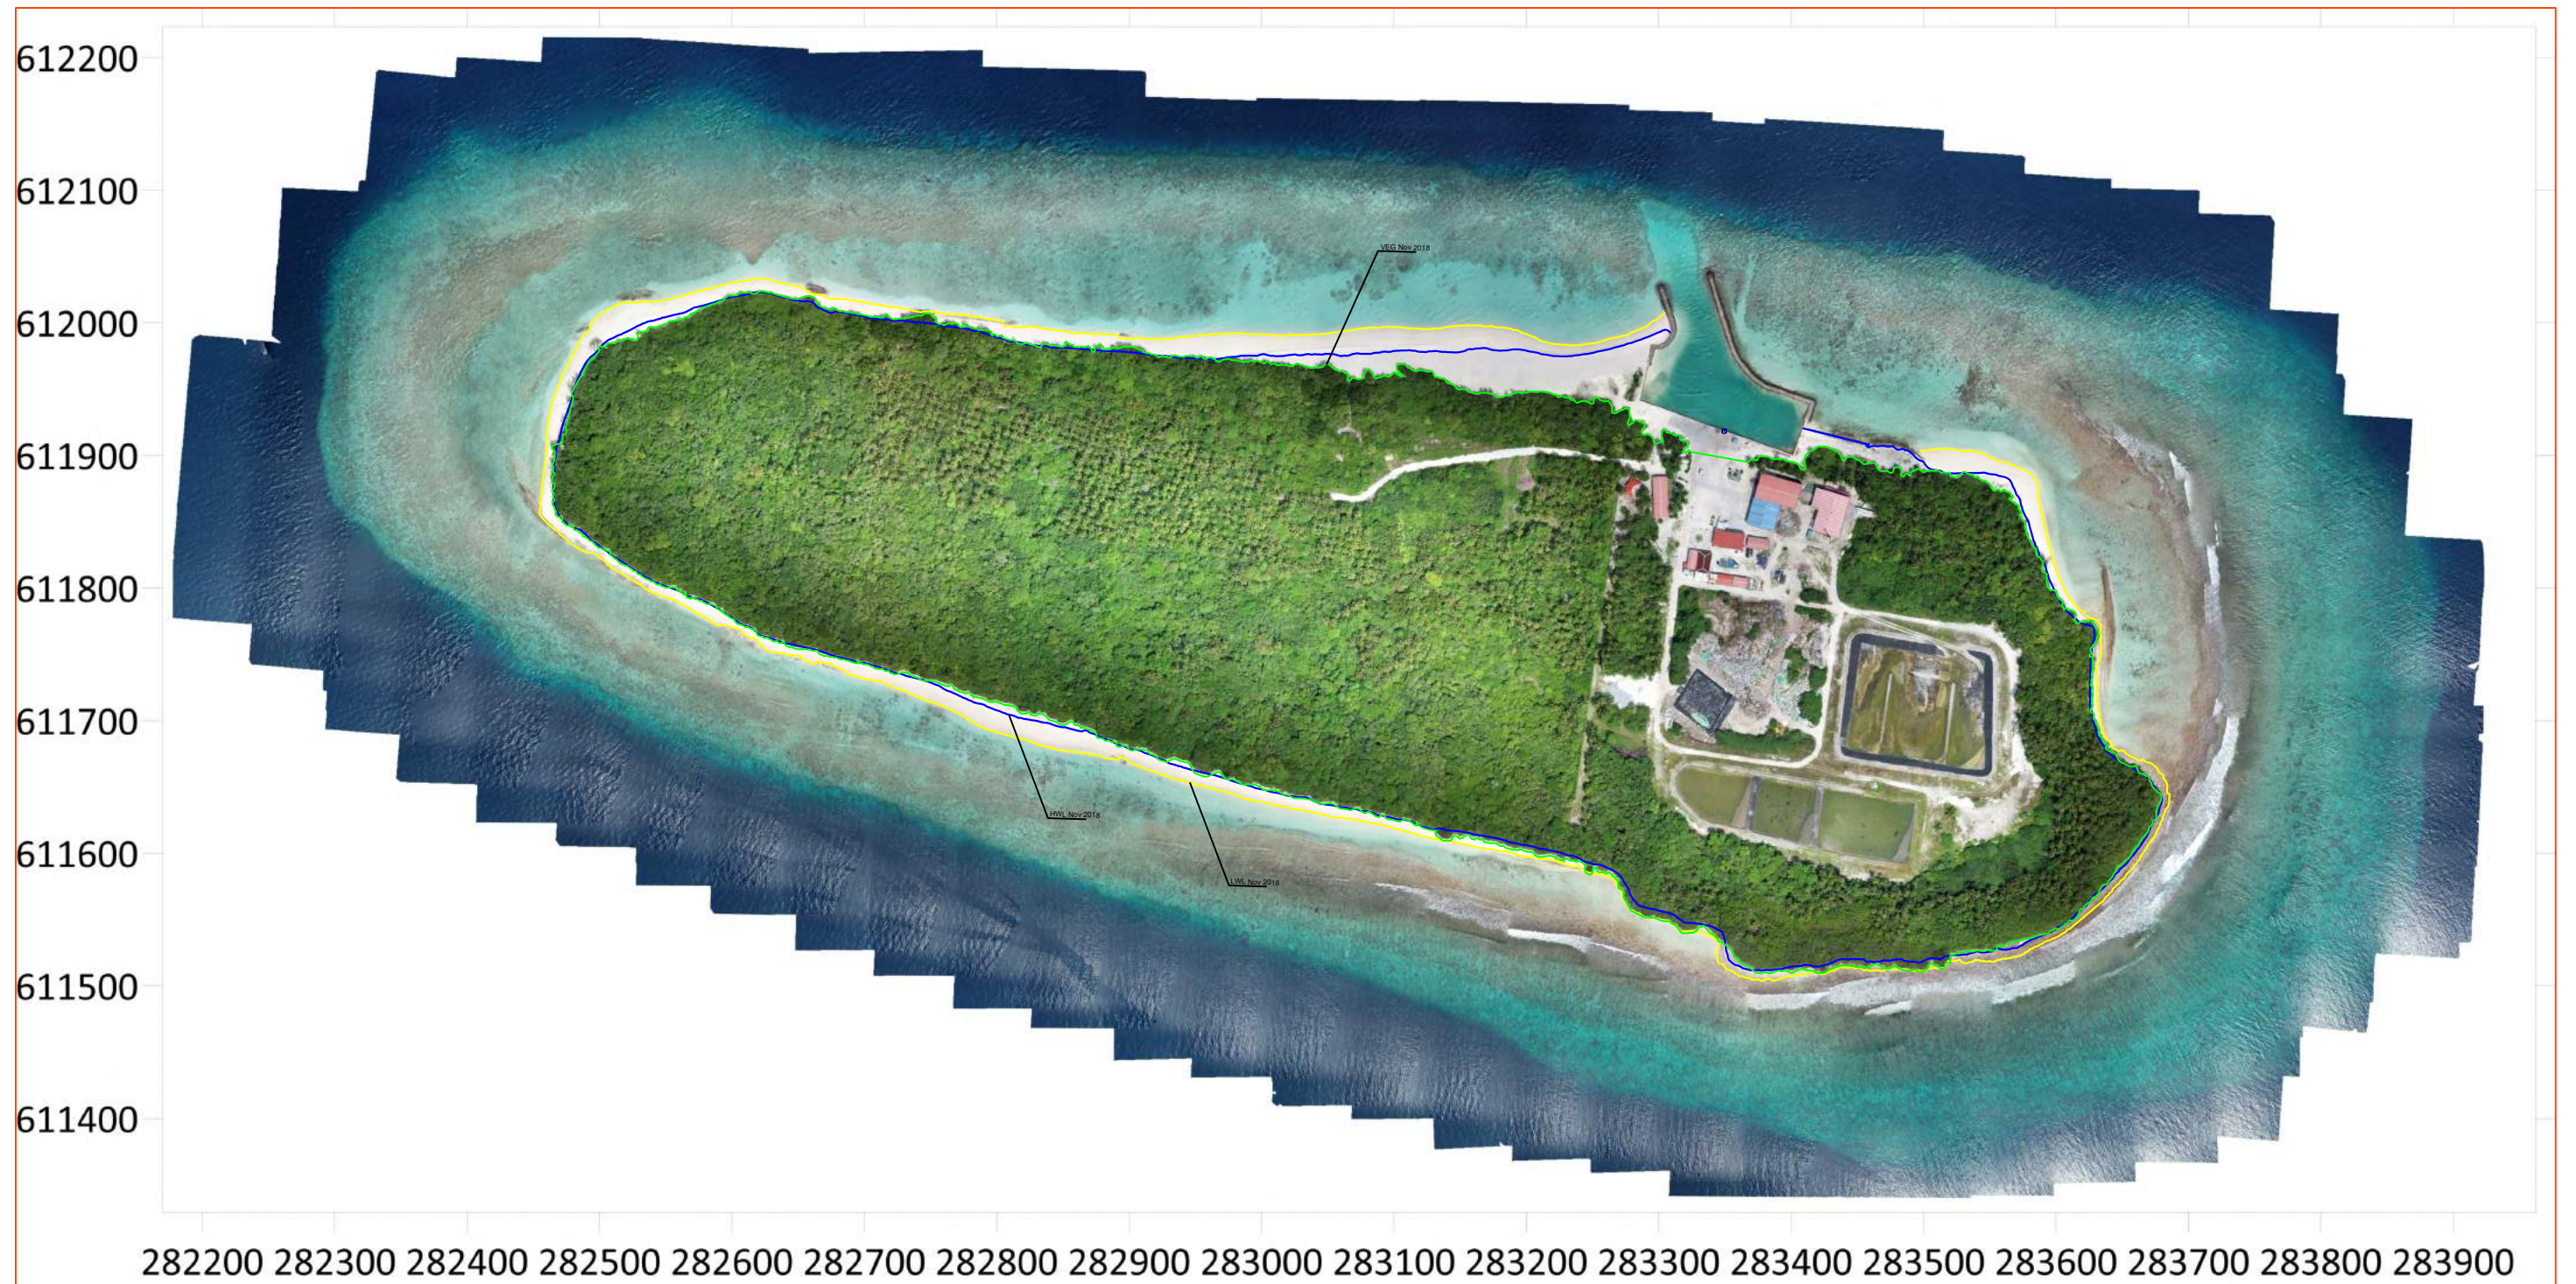
## R.VANDHOO SHORELINE SURVEY AND GEO-REFERENCED DRONE IMAGE

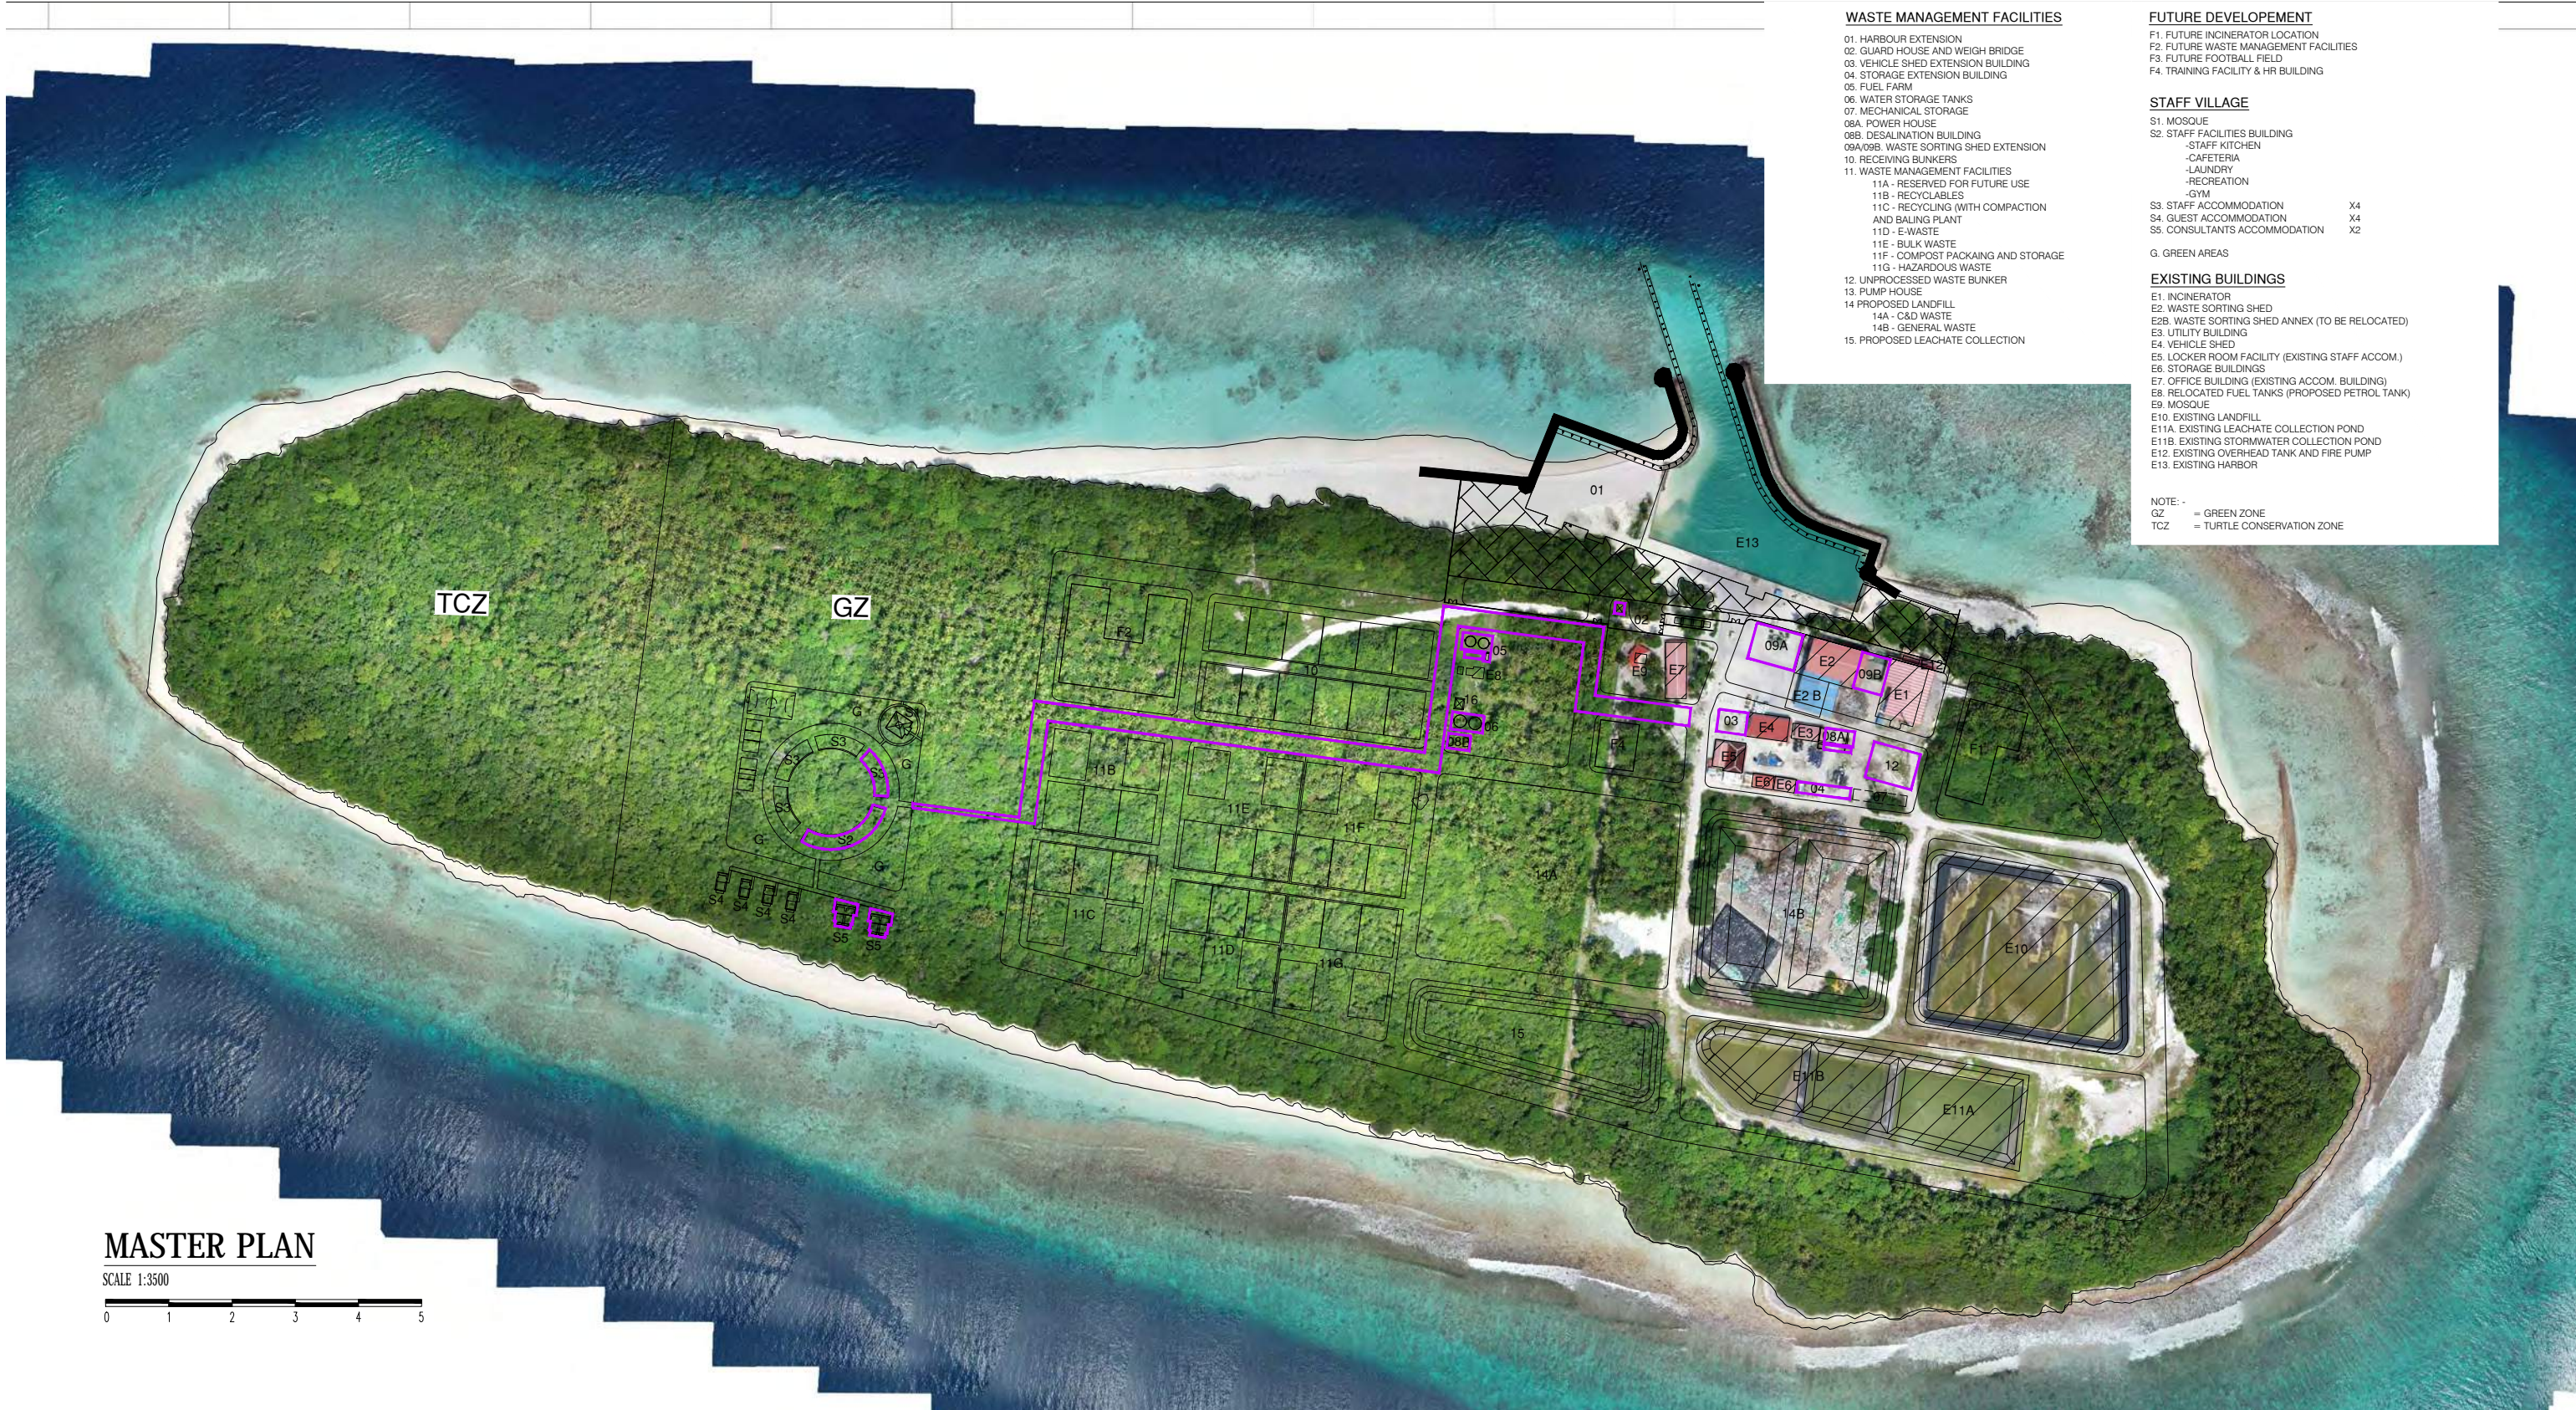
- WASTE MANAGEMENT FACILITIES**
- 01. HARBOUR EXTENSION
  - 02. GUARD HOUSE AND WEIGH BRIDGE
  - 03. VEHICLE SHED EXTENSION BUILDING
  - 04. STORAGE EXTENSION BUILDING

- 05. FUEL FARM
  - 06. WATER STORAGE TANKS
  - 07. MECHANICAL STORAGE
  - 08A. POWER HOUSE
  - 08B. DESALINATION BUILDING
  - 09A/09B. WASTE SORTING SHED EXTENSION
